Service Bulletin

Bulletin No.: 20-NA-045

Subject: Black Sealant Material Visible on Wheel Edge

Brand:	Model:	Model Year:		VIN:		Engine:	Additional Options (RPOs):
		from	to	from	to		
Cadillac	CT4	2020	2020			All	Equipped with TIRE ALL-235/40R18 SL 91V BW AL3-S (RPO Q4A)

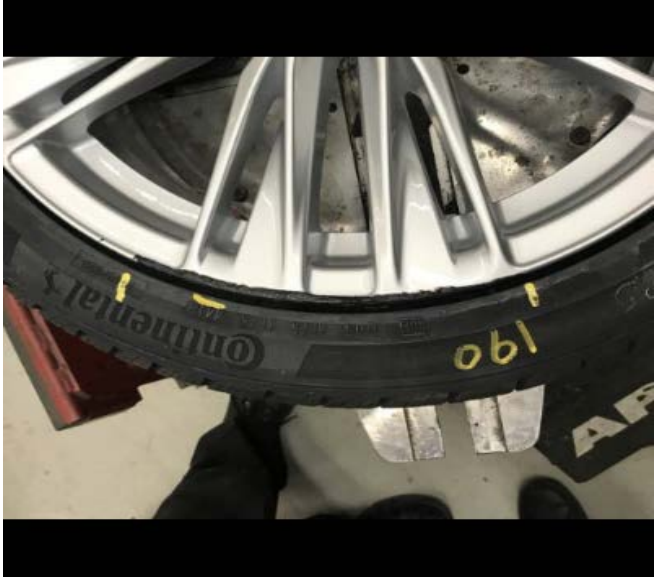
<p style="text-align: right; font-size: small;">5519310</p> <p>Some customers may comment on black sealant material visible on the edge of the wheel, resulting in a negative cosmetic appearance.</p>

If you encounter a vehicle with the sealant visible, clean the wheel using the tire bead and wheel mounting lubricant, GM Part Number 12345884 (U.S.) and 88863415 (Canada).

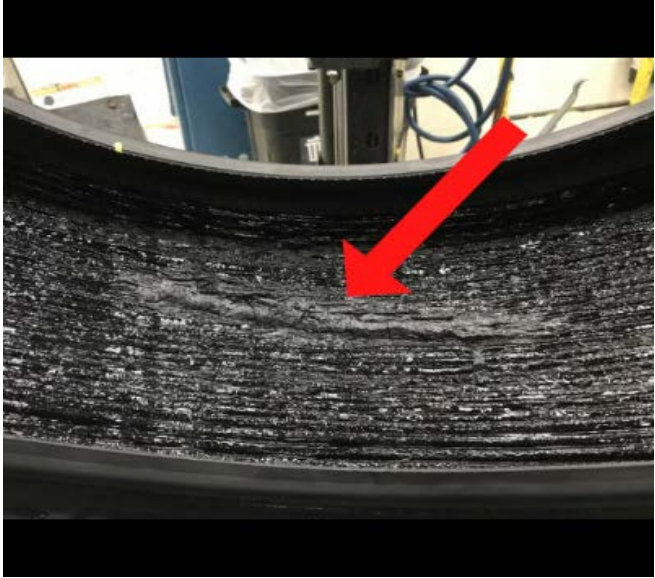
<p>5519311</p> <p>This may be caused by sealant material being transferred during the mounting process while using a clamp-type tire mouter.</p>
<p>Correction</p>	<p>If you encounter a vehicle with the above concern, clean the material off using the proper cleaning materials.</p>
