Technical Service Bulletin

91 Rattling noise from the lower (HVAC) MMI screen area

91 20 51 2054163/3 March 16, 2020. Supersedes Technical Service Bulletin Group 91 number 19-66 dated June 18, 2019 for reasons listed below.

Model(s)	Year	VIN Range	Vehicle-Specific Equipment
A6	2019	000001 - 076999	Not Applicable

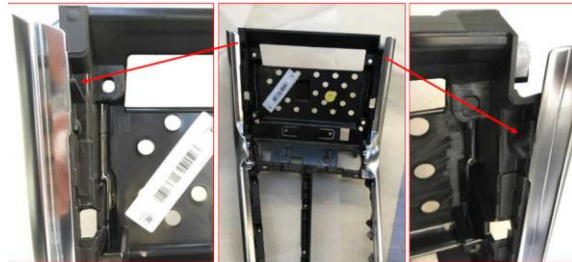
Figure 1. Center console trim.

If the plastic piece is not in direct contact with the trim (Figure 1), apply felt tape as shown.

Tip: Figure 1 depicts the center console insert (ETKA Illustration 863-052 Position 1). Figure 2, 3 and 4 all show the same lower dashboard trim (ETKA Illustration 857-017 Position 12).

1. Remove the center console trim.

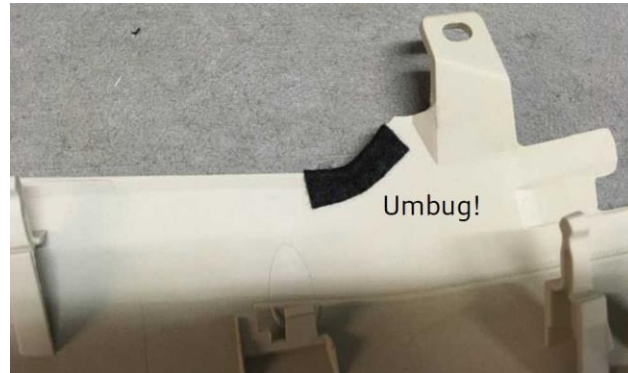
Figure 4. Apply the felt tape around the edge of the trim as shown.

2. Remove the dash trim and apply felt around the corners (Figure 2, 3 and 4).
