Technical Service Bulletin

93 Problems charging at home and/or after the DC charging plug is not releasing

93 20 21 2057353/3 March 27, 2020. Supersedes Technical Service Bulletin Group 93 number 20-17 dated January 24, 2020 for reasons listed below.

Model(s)	Year	VIN Range	Vehicle-Specific Equipment
Audi e-tron quattro	2019 - 2020	All	Not Applicable

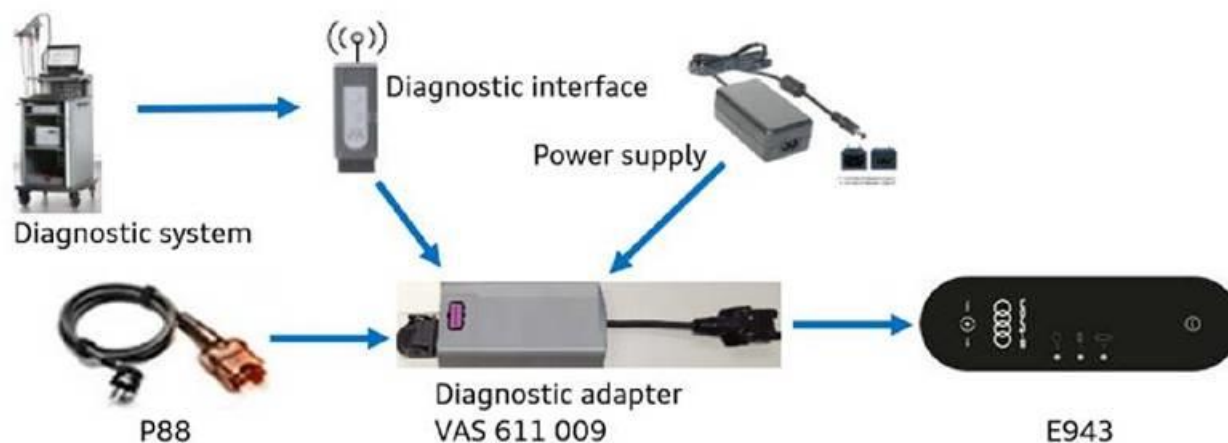
Figure 1. VAS 611 009.

Set up using VAS 611 009.

5. Update Audi mobile charger E943 using the SVM action code as listed in the table below, if necessary after following the instructions for setting up.
