<b>Technical Service Bulletin</b>	Transaction No:	2036935/16
<b>00-18-07 - By-Pack at Delivery (U.S. Only)</b>		Release date:	3/19/2020

## Condition

Applicable Vehicles					
Model(s)	Year	Eng. Code	Trans. Code	VIN Range From	VIN Range To
All Models	2017-2020	All	All	All	All

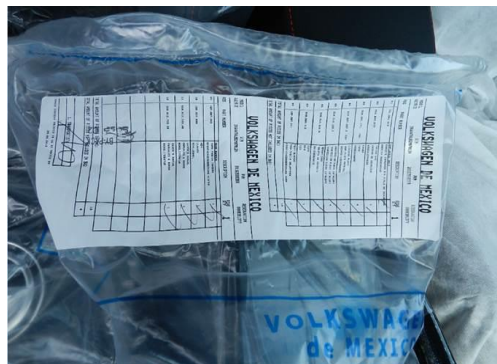
By-Pack is the term used to describe the bag that is delivered with the vehicle that contains the parts to be installed at PDI, i.e. Wheel Center Caps, Lug Caps, Wiper Blades, Etc. Figure 1.

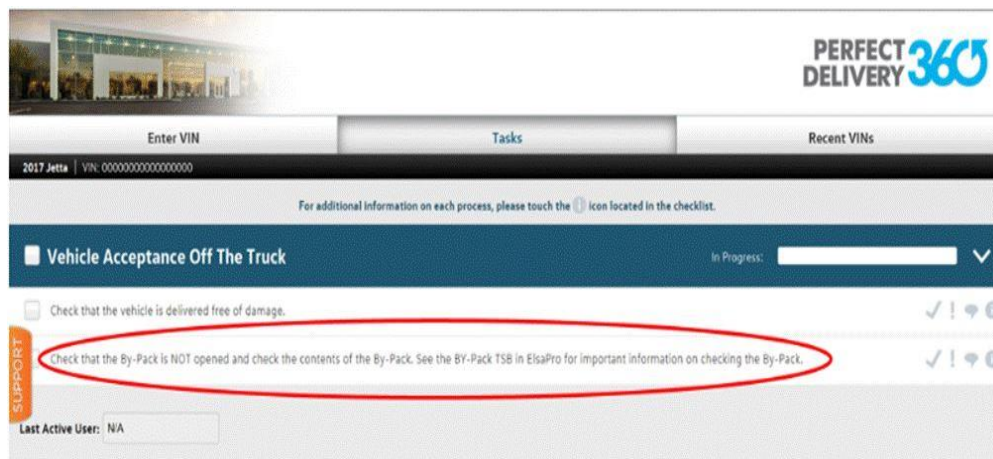
Figure 2.

Please note that the ePDI form has been updated to include the By-pack condition and content check at vehicle acceptance off the truck (Figure 2).

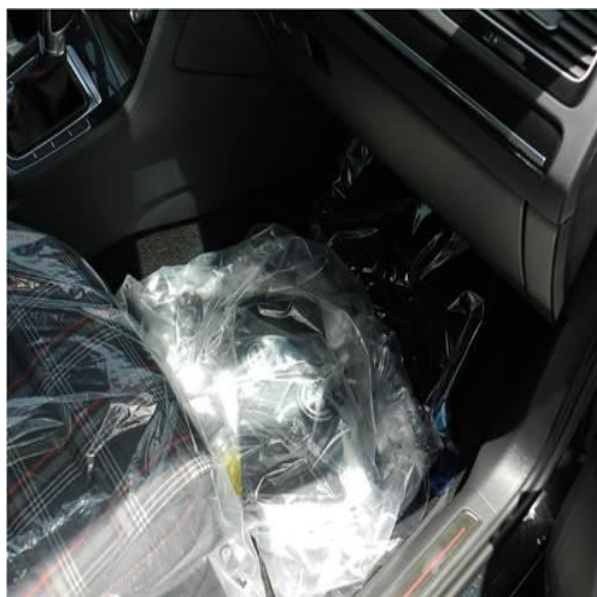
**Figure 5. By-pack Location for cars produced in Mexico**

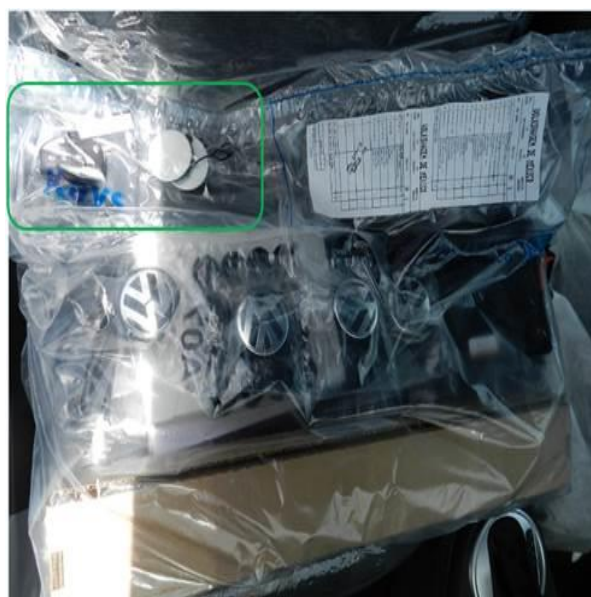
**Figure 6. Separation pouches for key(s) tow hook cover, etc.**

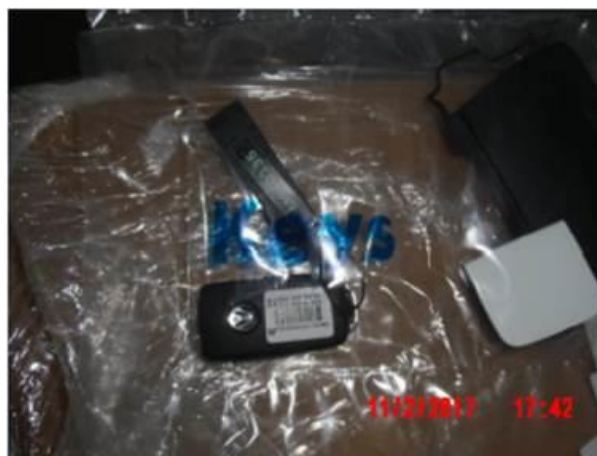
**Figure 7. One key in By-pack for cars produced in Mexico.**

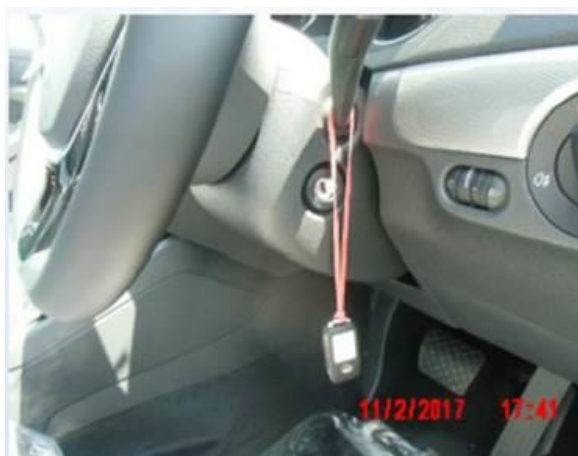
**Figure 8. One key tether to the wiper stalk for cars produced in Mexico.**

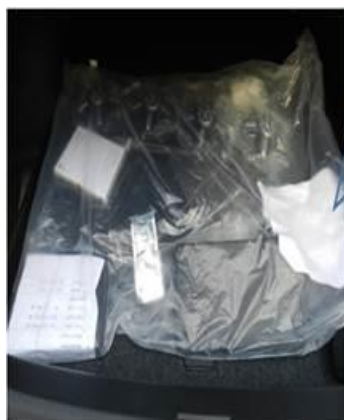
**Figure 9. Passat By-pack located in the luggage compartment**

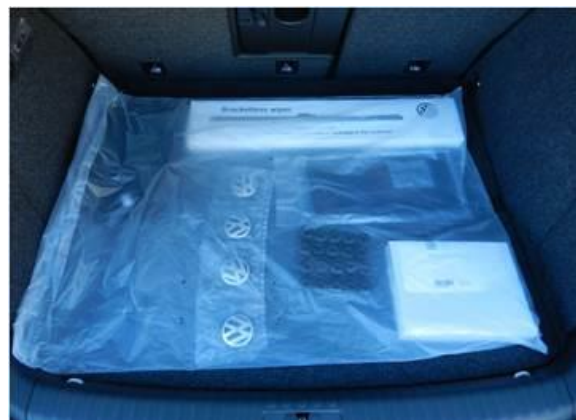
**Figure 10. Tiguan Limited By-pack located in the luggage compartment**

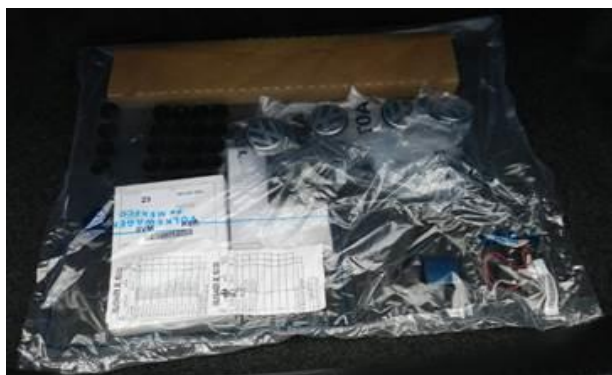
Figure 11.

Best Practice - At PDI **BEFORE** opening the By-Pack spread out the By-pack on a work bench or table exposing all the contents as best as possible and take a picture of the front and rear of the By-Pack (Figures 11 and 12). Make sure that the components labels with VIN is captured in the photo and check for missing components during this time.
