March 31, 2020

SUBJECT: **Customer Satisfaction Program 20N01**
 Certain 2015-2018 Model Year F-150 Vehicles
 Unintended Tailgate Opening

CERTAIN 2015 - 2018 MODEL YEAR F-150 VEHICLES — UNINTENDED TAILGATE OPENING

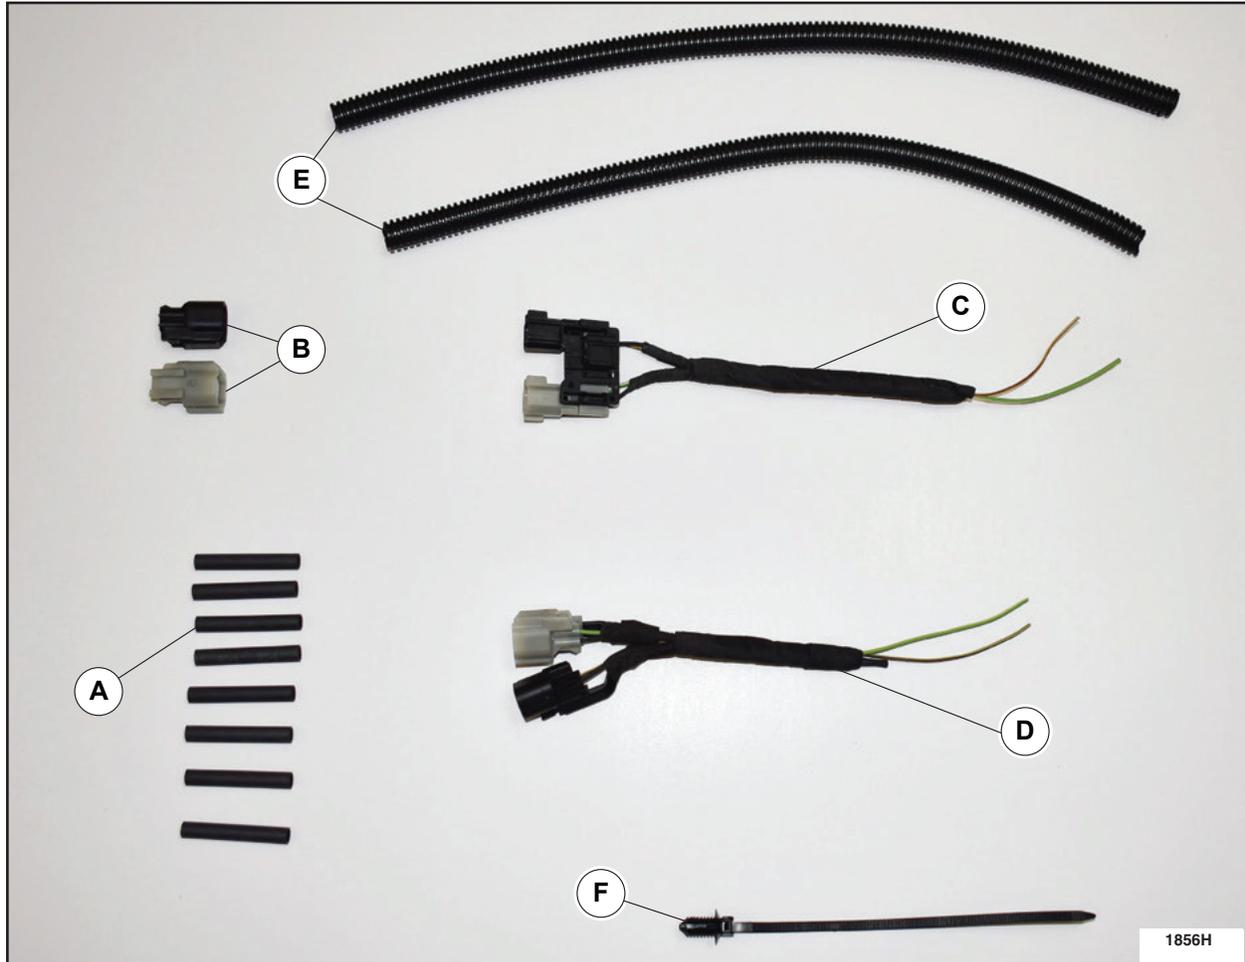
FIGURE 1

ITEM	DESCRIPTION	QUANTITY
A	Dual Wall Heat Shrink Tubing	8
B	Delete Caps	2
C	Male end of New Jumper Pigtail	1
D	Female end of New Jumper Pigtail	1
E	Convolute	2
F	Push Pin Tie Strap	1

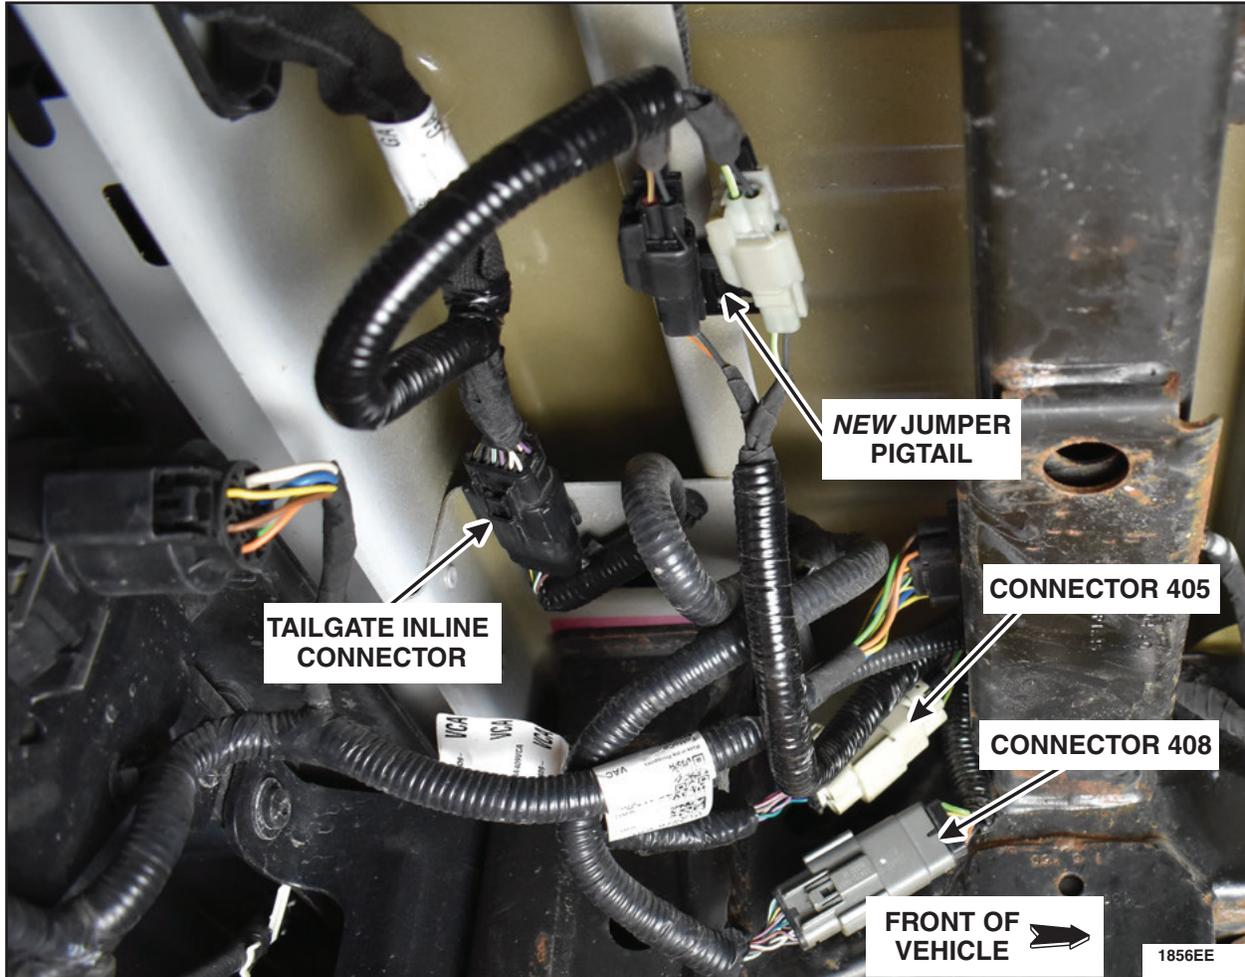
FIGURE 31

Completed Wiring Harness Modification
