# Technical Service Bulletin

## 97 Vehicle does not start DTC B11D729 stored, or functions of multifunction switch strip do not work

97 20 72 2059011/1 March 31, 2020.

Model(s)	Year	VIN Range	Vehicle-Specific Equipment
Q3	2019 - 2020	All	Not Applicable

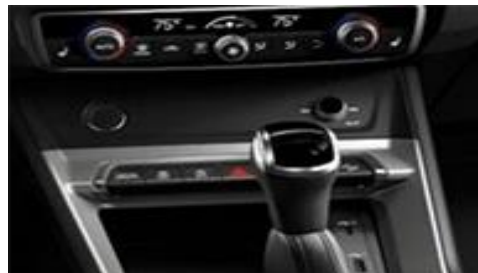
- One of the buttons on the multifunction switch may not work (Figure 1).

**Figure 1.** Engine start button and multifunction switch.

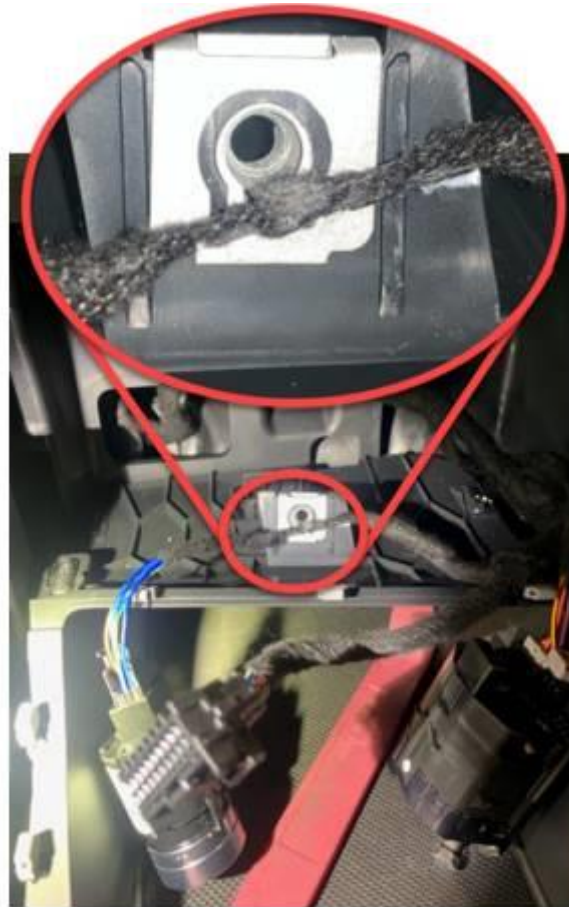
The wiring harness for the buttons of the multiple switch strip can get pinched between the mounting point of the storage compartment and the trim panel.

*Figure 1. Wiring harness pinched at the mounting point.*

Check for damage to the ignition switch and multifunction switch wiring, (Figure 1).

If the wires are damaged, repair the affected cables with the repair kit VAS 1978B.

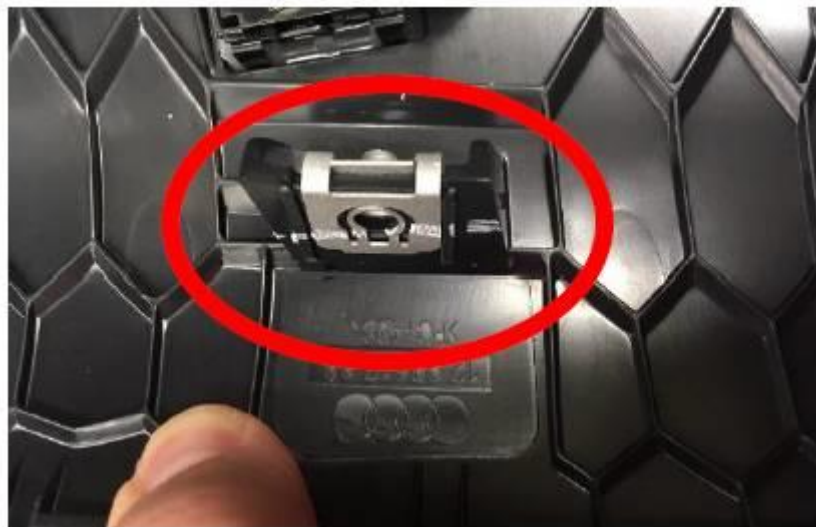
*Figure 2. Mounting lug to be removed.*

2. The mounting lug (Figure 2) must be removed.

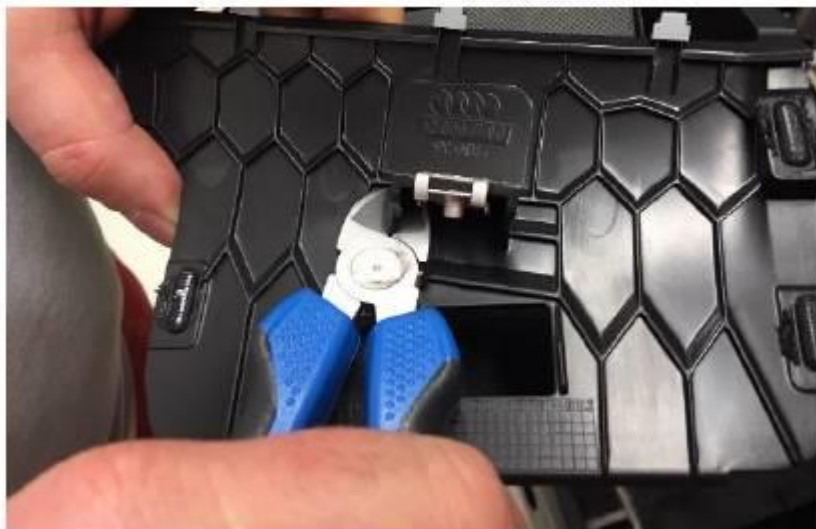
*Figure 3. Removal of support bars.*

3. With side cutters, remove the support bars at the right and left sides of the mounting point (Figure 3).

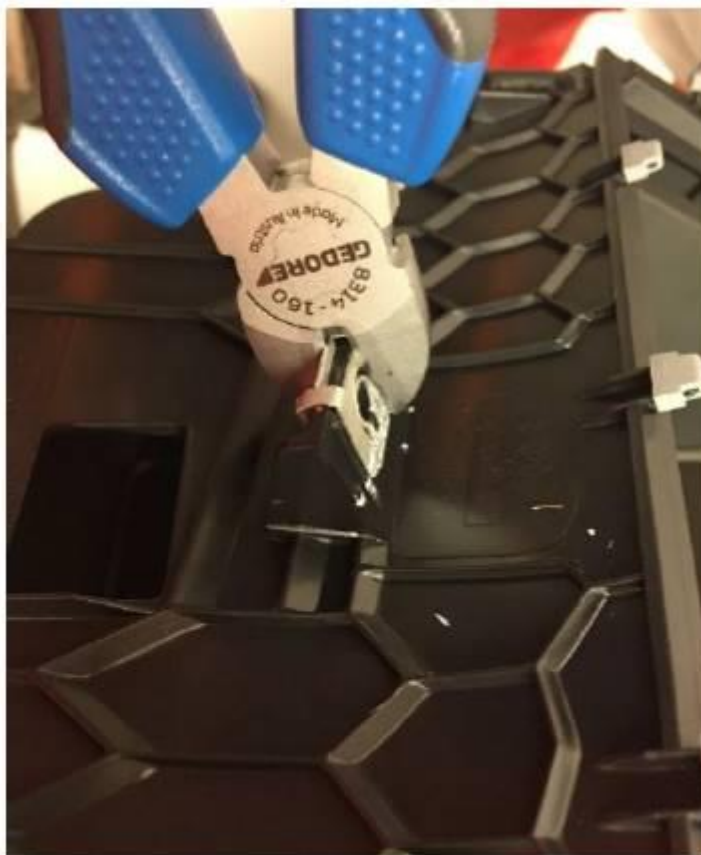
*Figure 4. Mounting lug can now be removed.*

4. The mounting point can then be removed using a twisting motion (Figure 4).

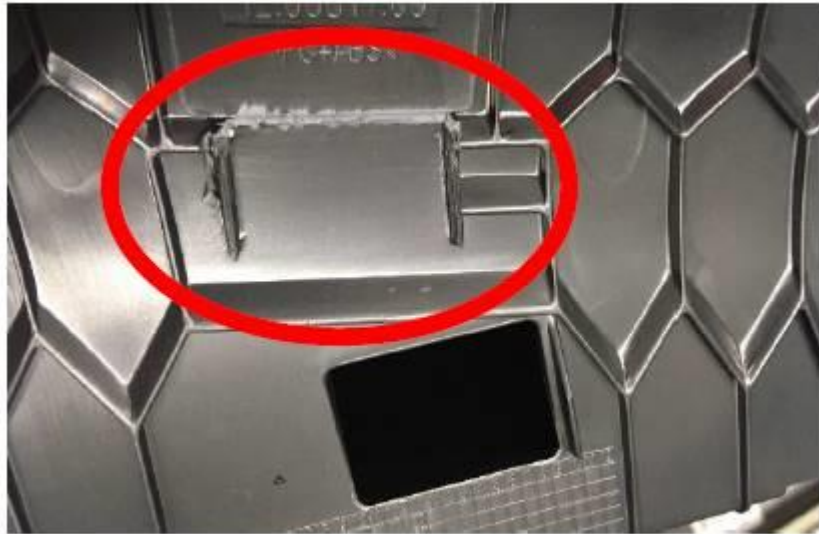
Figure 5. Example of finished removal.

5. Ensure no sharp edges are left that could interfere with harness routing (Figure 5).

Reinstall the storage compartment and check the functions of the related switches.
