**Symptom in Vehicle Interior - Ignition Starter Switch Jammed in Dashboard Trim Panel:  
Installing Washers (SY 155/19)**

Model line: **Cayenne (9YA/9YB)**

Model Year: **As of 2019 up to 2020**

Subject: **Ignition starter switch**

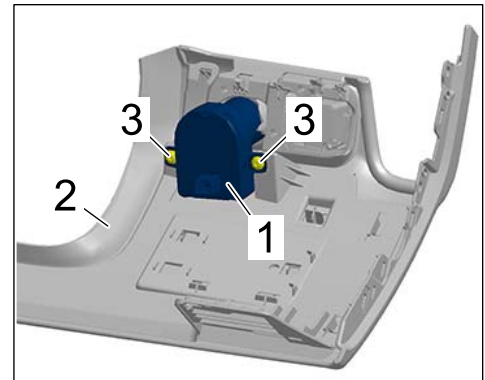
*Ignition starter switch*

Symptom: The ignition starter switch is jammed in the dashboard trim panel on driver's side.

Cause: Dimensional deviations of screw points for ignition starter switch.

Work Procedure: 1 Remove ignition starter switch ⇒ *Ignition starter switch -1-* from dashboard trim panel on driver's side ⇒ *Ignition starter switch -2-*.

1.1 Unscrew and remove screws ⇒ *Ignition starter switch -3-*.

1.2 Guide ignition starter switch ⇒ *Ignition starter switch -1-* out of dashboard trim panel on driver's side ⇒ *Ignition starter switch -2-*.
