Eliminating Symptoms - Engine: Reworking Coolant Pipe (Loss of Coolant at the Coolant Pipe/SY14/16)

Symptom: Customer complaint about loss of coolant, visible on the underside of the engine/where the vehicle was parked. Sometimes a yellow warning comes on in the instrument cluster with the information message "Refill coolant Be careful of engine temperature".

Cause: Component tolerances between the coolant pipe flange and distributor housing can cause leaks.

Remedial Action: In the event of a customer complaint, install additional "water tube retaining bar".

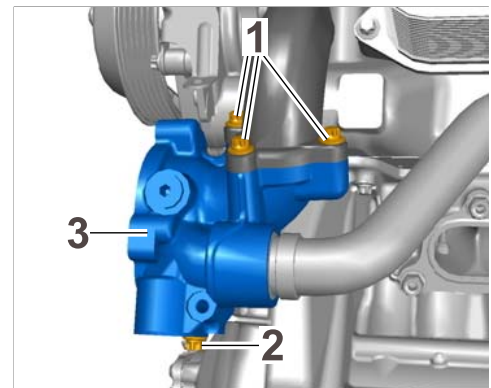
Coolant pipe on coolant regulator housing

- 2 Unscrew screws ⇒ *Coolant pipe on coolant regulator housing -1-* on the coolant regulator housing
⇒ *Coolant pipe on coolant regulator housing -3-*.
