Noise Symptom – Squeaking Noise When Steering: Grease Steering Column Sealing Bellows (SY 22/20)

Model line: **Taycan (Y1A)**

Model Year: **As of 2020 up to 2021**

Subject: **Steering column sealing bellows**

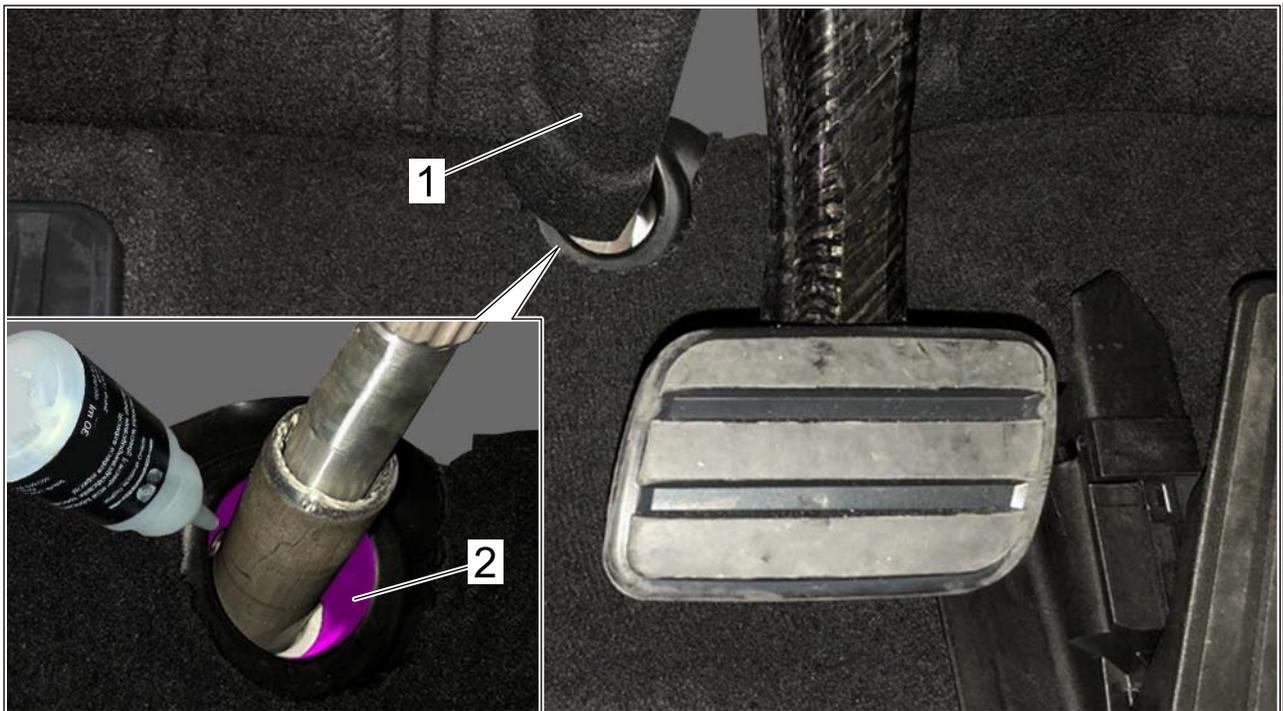
Steering column sealing bellows

Symptom: Squeaking noise from the steering column area during steering movements. The intensity depends on the steering wheel height adjustment position.

Cause: The steering-column sealing bellows can cause squeaking noises.

- 1.2 Detach the universal joint ⇒ *Universal joint on power-steering gear -1-* from the power-steering gear ⇒ *Universal joint on power-steering gear -3-*.
- 2 Lift up the trim panel ⇒ *Steering column sealing bellows -1-* in the driver's side footwell slightly.
- 3 Spread the lubricant all over the inner lining of the steering column sealing bellows ⇒ *Steering column sealing bellows -2-*.
