**Transmission Symptom - Transmission Oil Leaks Out When Driving on Race Circuits:
Replacing Vent Line for Clutch Chamber (SY 130/19)**

Vehicle Types: **911 GT3 (991)/911 GT3 RS (991)**

Model Year: **As of 2014 up to 2019**

Subject: **Vent line for clutch chamber**

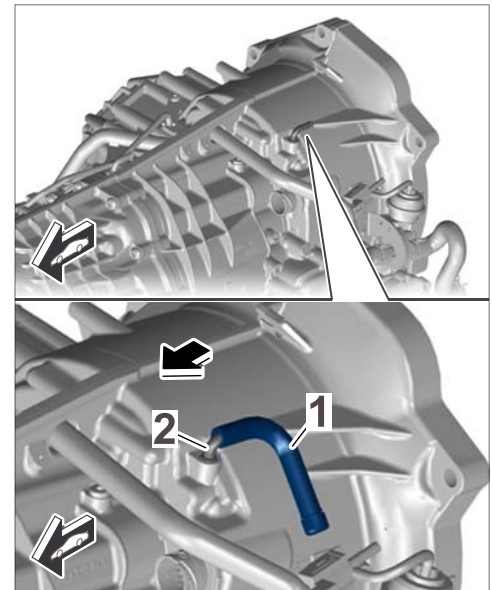
Vent line for clutch chamber

Symptom: Transmission oil leaks out of the vent line for the clutch chamber when driving on race circuits.

Cause: Highly dynamic driving on race circuits at high engine speeds causes oil foaming and can result in an oil leak from the PDK vent line on the clutch side in some cases.

Work Procedure: 1 Disconnect vent line for clutch chamber ⇒ *Vent line for clutch chamber -1-* from breather pipe ⇒ *Vent line for clutch chamber -2-*.
