WKJ9 - Re-Programming Control Unit for Assistance Systems (Workshop Campaign)

Model line: 911 (992)

Subject: Control unit for assistance systems

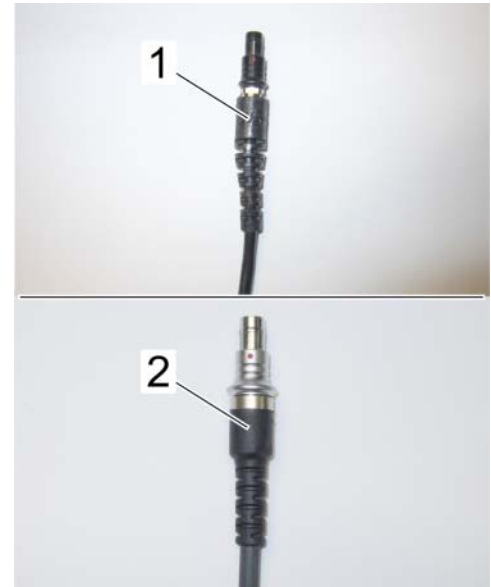
Use the **new** PIWIS Tester data cable to carry out the campaign. The difference between the old ⇒ *PIWIS Tester data cable -1-* and new ⇒ *PIWIS Tester data cable -2-* data cable is shown in the illustration.

If the connection between the vehicle and PIWIS Tester is interrupted, check the data cable for the PIWIS Tester for signs of damage. If the data cable is damaged, it **must be replaced**. To do this, follow the instructions in the PPN for "Returning faulty USB cable caps" (PPN portal > Dr Ing. h.c. F. Porsche AG > Aftersales > Workshop > PIWIS > Documents).
