Technical Service Bulletin

CLICK OR SQUEAK NOISE FROM FRONT BRAKES

Bulletin No.: 04-004/20

2016-2020 CX-9

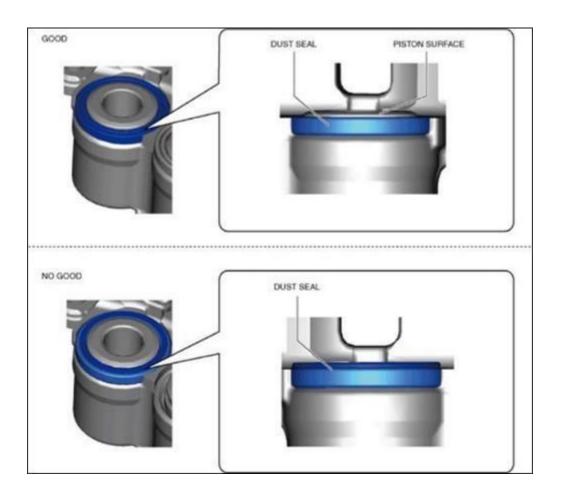
7. Verify that the dust seal installation position is lower than the piston surface (as shown below).

• If the dust seal protrudes from the piston surface, install the SST (as shown below) and press the dust seal back to the correct position.
