SERVICE PROGRAM BULLETIN

APPLICABILITY: 2019MY Crosstrek
SUBJECT: Rear Seat Belt Webbing Locking

NUMBER: WRA-20R
DATE: 02/25/20
REVISED: 03/05/20

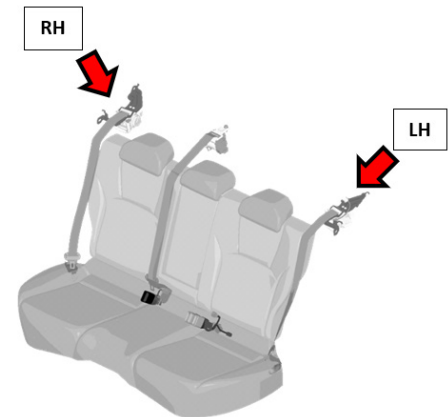
NOTE: Position Code and ID Code details are provided in the Service Procedure section below.

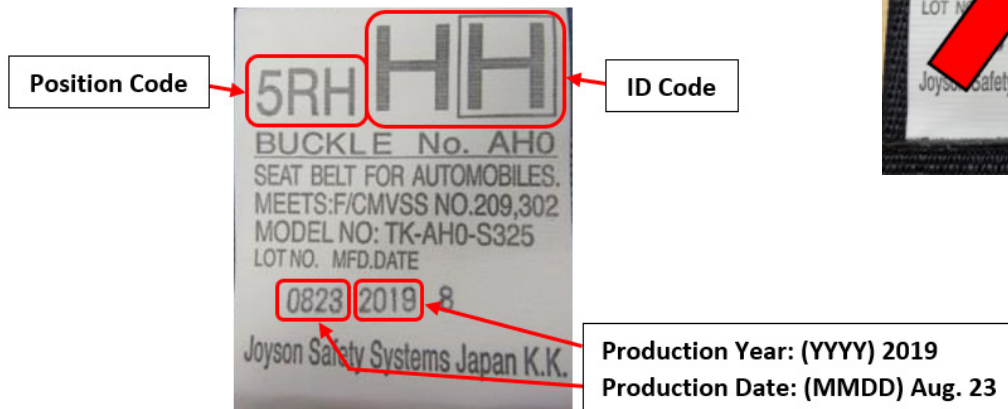
- **After seat belt removal, mark the tag with a permanent marker** as shown here to distinguish the old part from the replacement (new) part. If by chance the old parts become confused with the new parts, check the date code to identify the new seat belt assemblies using the photo below as a guide.
