## Instrument Cluster Reprogramming (MID 140) GU, GR

### PI0889 Differential Lock Engagement Status Alarm Update (MID 140)

**(March 2020)**

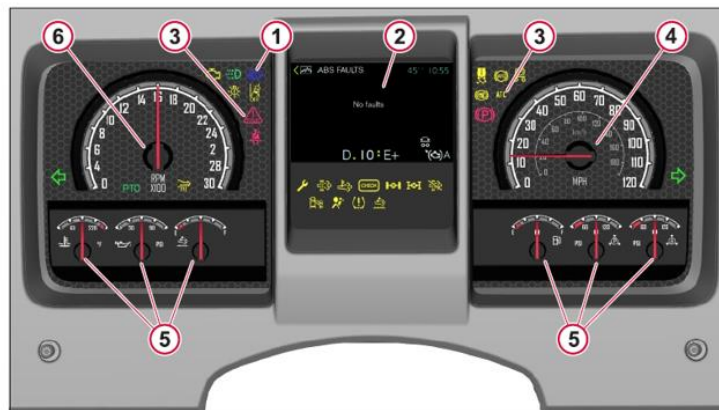
\*Current Software\*

**Diff-Lock Engaged:** (Popup + audible + Icon) Begins

**Popup** = 30sec

**Audible** = 5sec

**Icon** = Continuous

**Diff-Lock Disengaged:** (Popup + audible + Icon) End

**Popup** = No

**Audible** = No

**Icon** = No

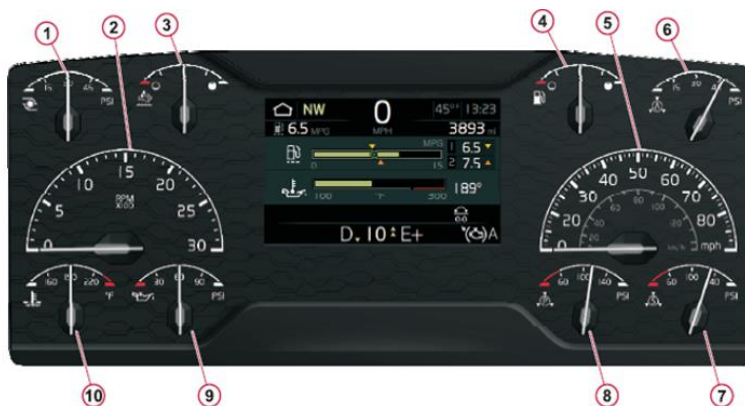
\*Current Software\*

**Diff-Lock Engaged:** (Popup + audible + Switch Display) begins

**Diff-Lock Disengaged:** (Popup + audible + Switch Display) End

**Popup** = 5sec

**Buzzer** = 5sec

**Switch Display** = Continuous

**Popup** = No

**Buzzer** = No

**Switch Display** = No
