| Title | Mack Chassis - Rear Drive Transverse Torque Rod Bracket Failure; Torque Rod Bracket Broken/Studs Broken On Rear Carrier |

| <b>Mack Model</b> | LEU , LR , MRU - TerraPro , TE - TerraPro , AN - Anthem , CHU - Pinnacle, Axle back , CXU - Pinnacle, Axle front , GR - Granite , GU - Granite , PI - Pinnacle , TD - Titan |

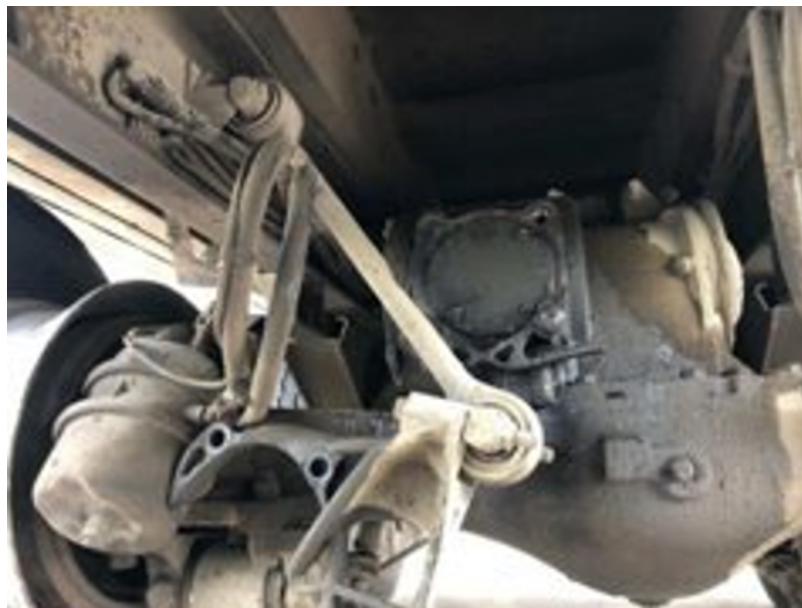
| Cause | Vehicles meeting the criteria for this solution may experience failure of the rear drive transverse torque rod bracket. An example is shown below: |

This issue was found to have begun following the introduction of a newer lightweight bracket for the torque rod. Failure occurs after the studs loosen on the rear of the carrier, or when the bracket does not sit flat on the carrier. This pushes the load in to the torque rod bracket.

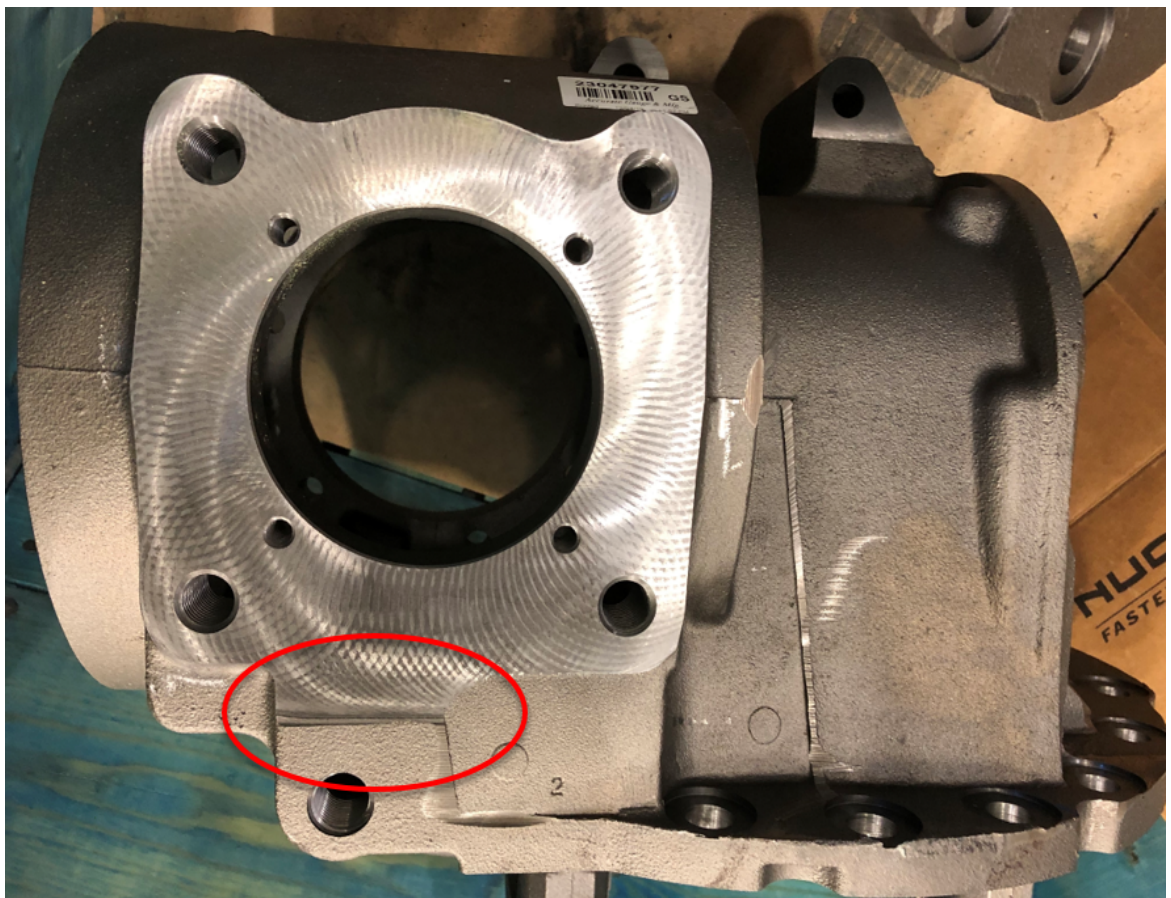
**If the bracket is found to not be flush with the carrier housing** follow the steps below:

1. Inspect for a raised boss area on the carrier. An affected area is circled in the picture below:

2. Remove the studs from the housing.
3. Grind the raised area smooth to match the flat surface for the bracket. Be careful to grind the area smooth so no cracks form.
4. Clean and re-install the studs with Loctite 263. **Torque to 225-275 lb-ft (305-373 Nm).**

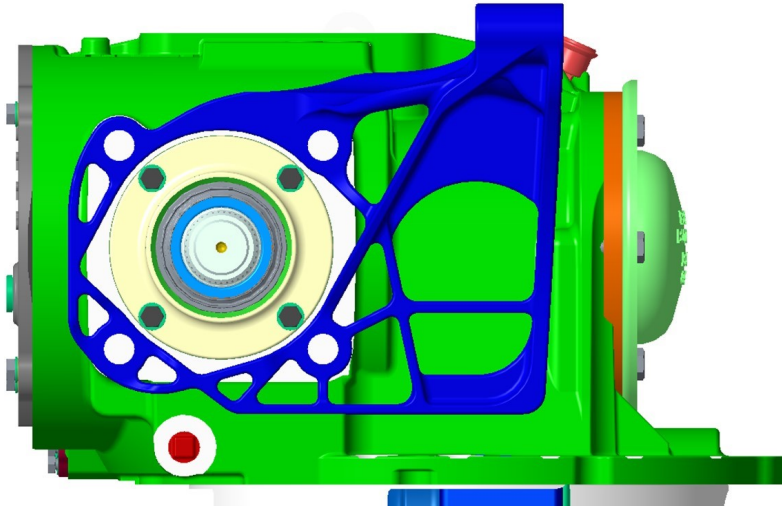
**Bracket 22539545**

- The affected bracket part number is [22539545](#). It is also possible that this issue can be encountered with part [21593018](#).
- **NOTE:** Multiple previous part numbers supersede to the numbers above. The part number should be obtained from the bracket itself.
