SERVICE BULLETIN

APPLICABILITY: 2019-20MY Forester

NUMBER: 12-258-20

SUBJECT: Rattling Sound from Sunroof Deflector

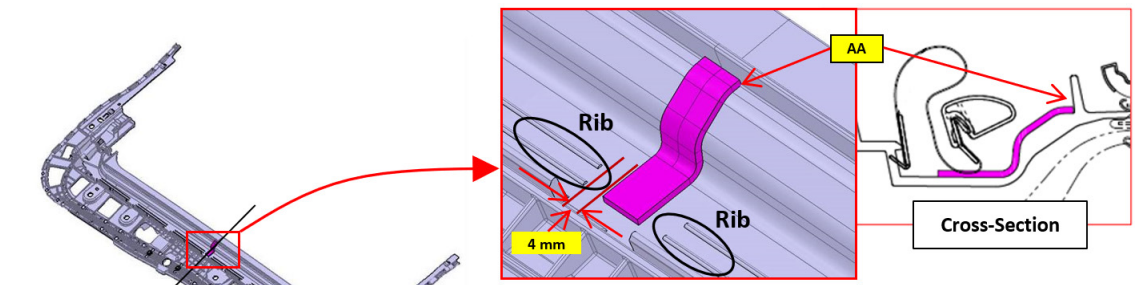
This bulletin provides a procedure for addressing a rattling sound caused by the sunroof deflector contacting the sunroof rail assembly. The sound may be heard while closing an outside door when all the windows are closed. Although a new sunroof rail assembly is now available incorporating a cushion to prevent the sound, a cushion (section of non-woven tape material) can be retrofitted to existing parts to alleviate the condition using the procedure supplied in this bulletin.

- Open the sunroof for access to the frame assembly where the cushion will be installed.
- Identify the location for where the cushion will be installed using the illustrations below and thoroughly clean the area of the frame using isopropyl alcohol on a clean shop cloth. Allow to dry completely before proceeding.

Peel the backing and CAREFULLY apply the new Cushion to the rail between the ends of the left / right ribs. Make sure the cushion end fits into the corner as shown (AA) and there are no gaps between the cushion and the rail.
