## Service Bulletin

**02-157**

Model 567 and 579 Windshield Delamination

3/4/2020

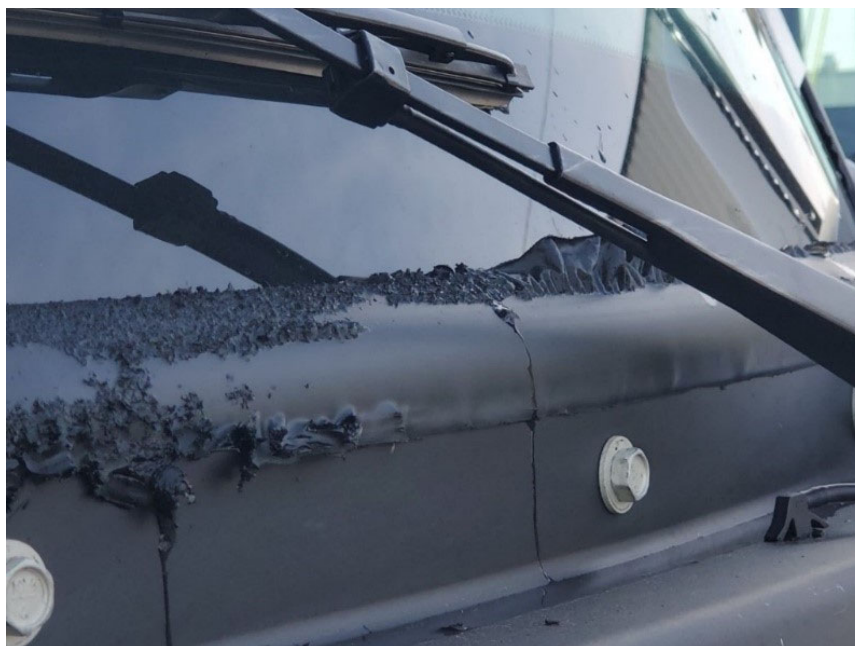
Certain model 567 and 579 vehicles may have been built with a windshield seal that could delaminate. Vehicles built from 9/27/2019 through 2/06/2020 with windshield Julian date codes between 263 of 2019 and 031 of 2020 could be affected.

1. Inspect the windshield for signs of delamination as shown in the picture below.

2. Take a clear picture of the delamination to be submitted with the warranty claim.
3. Replace the windshield.
4. If the vehicle is equipped with a Bendix Fusion camera attached to the windshield (windshield R44-6092 in WebECAT), refer to the attached Bendix Fusion Camera Service Data document for the installation procedure.
