## IMPORTANT SAFETY RECALL

Subject: Safety Recall 19PBF Model 520 RHSU Front Spring Bracket  
NHTSA 19V917  
EXPIRATION DATE: NONE

## Federal Recall Information

**19PBF**

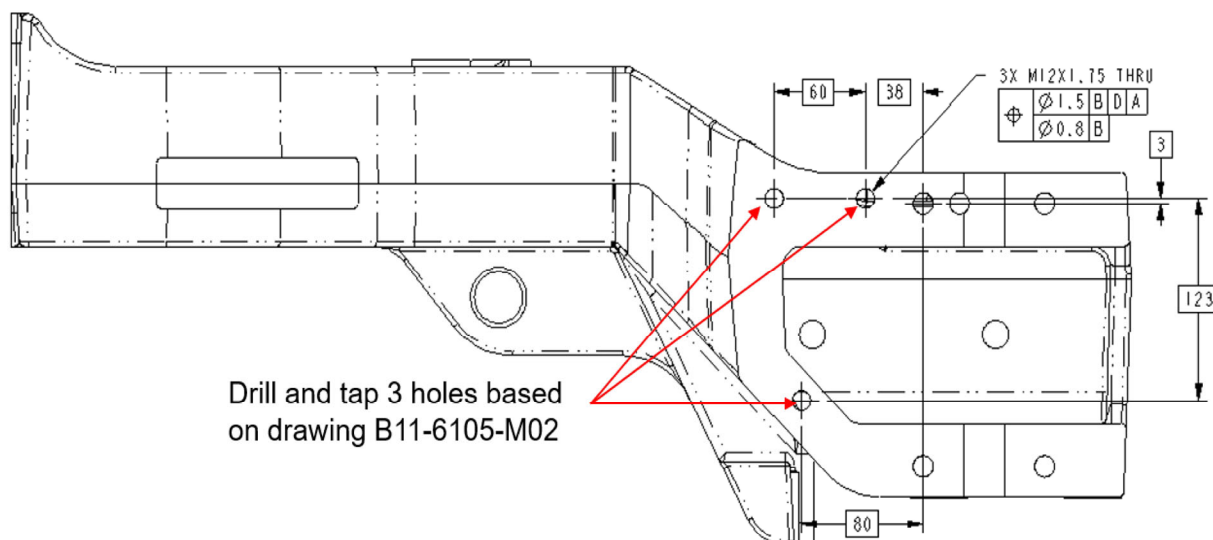
Certain Model 520 vehicles with Right-Hand Standup (RHSU) configuration may have an improperly supported steering gear assist bracket

Peterbilt Motors Company has decided a defect, which relates to motor vehicle safety, may exist in certain Model 520 vehicles with Right Hand Stand Up (RHSU) configuration built between June 15, 2018 and February 14, 2019. Vehicles may have an improperly supported steering gear assist bracket due to the incorrect spring bracket installed. The spring bracket may be missing 3 drilled and tapped holes which will provide additional support for the steering gear assist bracket.

- Inspect the steering gear assist bracket to ensure it is mounted with all 5 bolts. If all 5 bolts are installed. No further action is required.
- Replace the steering gear bracket, drill and tap 3 holes per drawing B11-6105-M02R and mount the new steering gear assist bracket to the spring bracket with 5 new bolts and washers. See image below.

1. Drill – 10.3mm or 13/32 drill
2. Tap – M12 X 1.75
