Technical product information

Topic	Rotating screen alignment
Market area	Bentley: worldwide (2WBE),Hongkong-Macau (5HK)
Brand	Bentley
Transaction No.	2051526/4
Level	EH
Status	Approval
Release date

New Continental GT - New Continental GTC and New Flying Spur

Bentley Rotating Display “BRD” adjustment overview

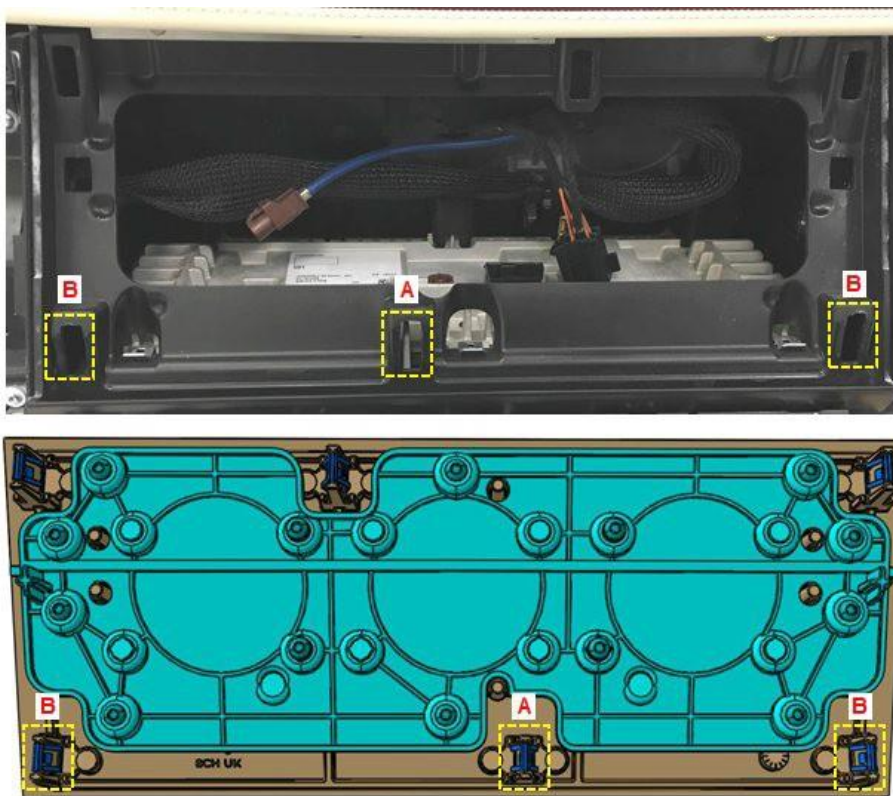
Figure 1

The veneer face fasciapanel is fixed to the “BRD” by six locator pins and receiving holes. See Figure 1.

The following locator pins (A & B) control the position of the fascia panel as follows:

A = Side to side axis

B = Up and down axis

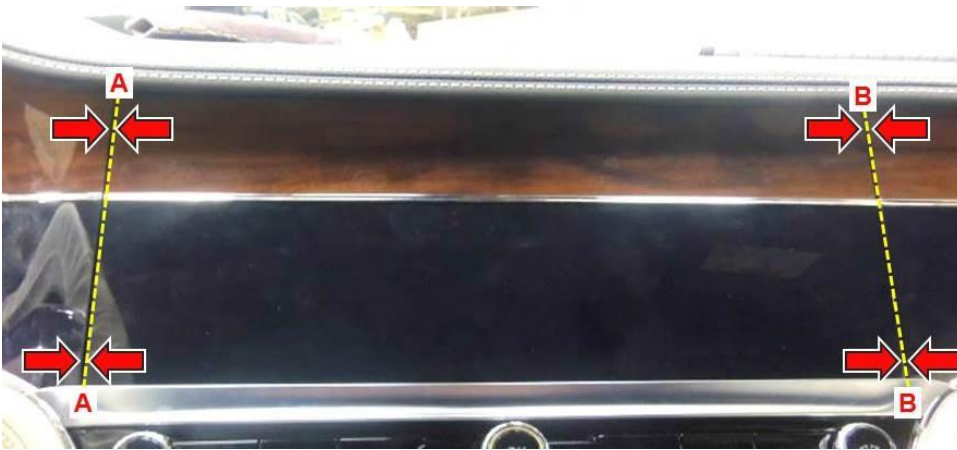
Figure 2

Measure the gaps (A & B) between the veneer face fascia panel and the passenger and drivers side fascia panels. See Figure 2.

The specified gapping is 1.5mm +/- 0.5mm tolerance. The gap between the "BRD" veneer face fascia panel and passenger and drivers side fascia panels **MUST** be parallel on both sides.

If the gaps are not within the specified values then adjust as follows.

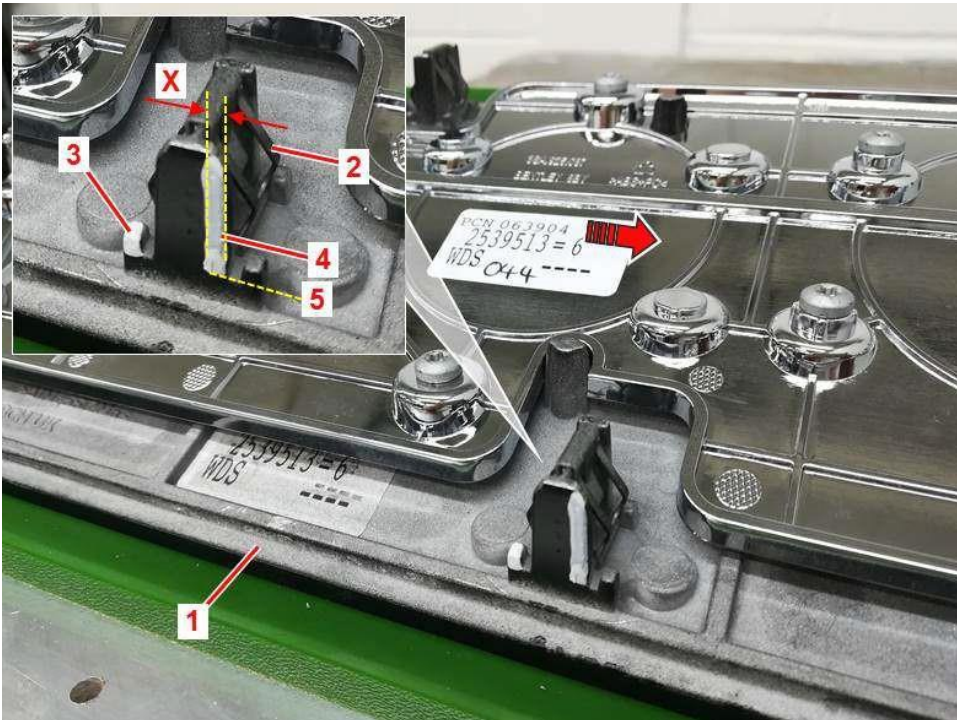
Figure 3

i Only the centre lowermost locator pin shown governs the side to side movement of the fascia panel. Only this locator pin will require modifying.

Place the veneer face fascia panel (1) face down on a soft, clean and protective work surface and mark accordingly the direction in which the panel needs to move (arrow). See Figure 3.

Remove the spring retaining clip (2) from the lowermost locator pin. If the fascia panel requires moving by 0.5mm then remove the same amount of material (X) from the appropriate side of the lower centre locator pin (4) as shown on the aluminium substrate casting. In addition, file the trailing RPS point (3) flat, level with the recess. See Figure 3.

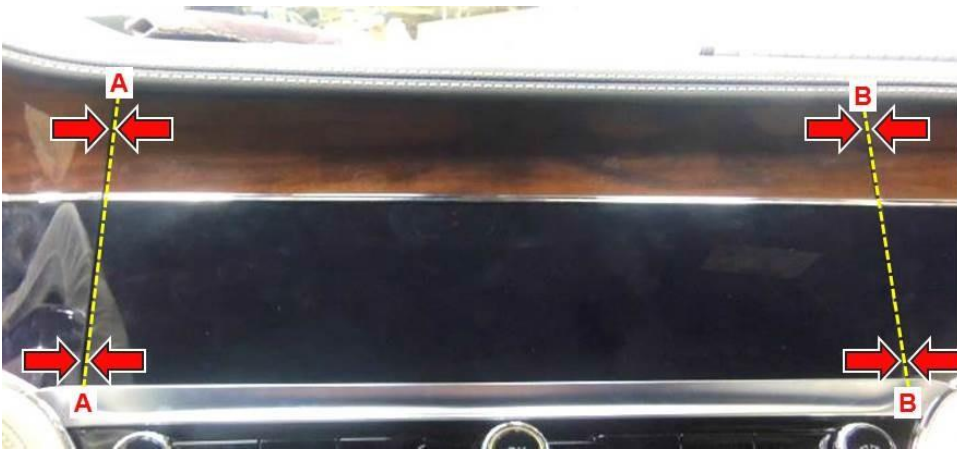
Figure 6

Again measure the gaps (A & B) between the veneer face fascia panel and the passenger and drivers side fascia panels. See Figure 6.

The correct gapping is 1.5mm +/- 0.5mm tolerance. The gap between the veneer face fascia panel and passenger and drivers side fascia panels MUST be parallel on both sides.

If the gaps are not within the specified values then add/remove anti-creak tape to adjust accordingly.

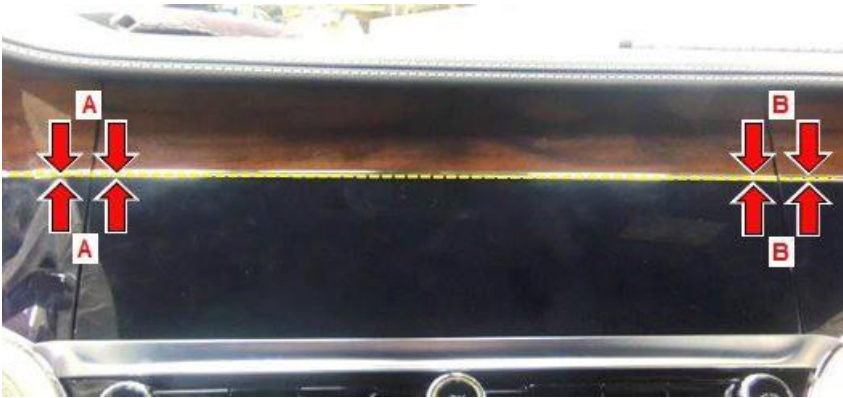
Figure 7

Visually check that the chrome brightware strip on the "veneer face" fascia panel is aligned with the chrome strips at points A & B on the passenger and drivers side fascia panels. See Figure 7.

The specified tolerance in the vertical plane (A & B) is 0.5mm.

If the chrome brightware strip on the "veneer face" fascia panel is out of line, carry out the following to adjust the panel.

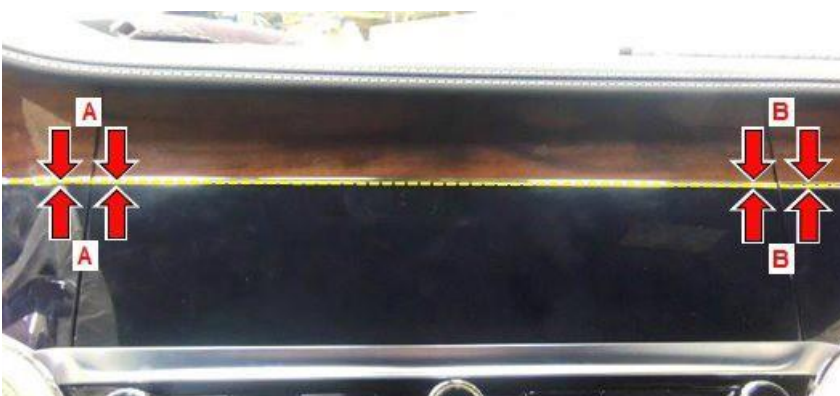
Figure 10

Visually check that the chrome brightware strip on the "veneerface" fascia panel is aligned with the chrome strips at points A & B on the passenger and drivers side fascia panels. See Figure 10.

The tolerance in the vertical plane (A & B) is 0.5mm.

If the chrome brightware strip on the “vener face” fascia panel is still out of line, and is not within the specified tolerance then add/remove anti-creak tape to adjust accordingly.

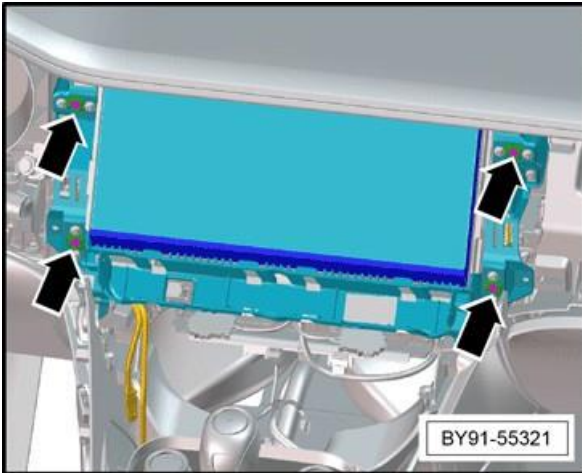
Figure 11

Under no circumstances should any attempt be made to adjust the “BRD” module inboard or outboard by adjusting any of the four setting screws (arrows) shown in Figure 11.

The setting screws (arrows) are factory sealed and any attempt to make adjustments via these four screws may result in failure of the rotating display and/or information display touch screen.

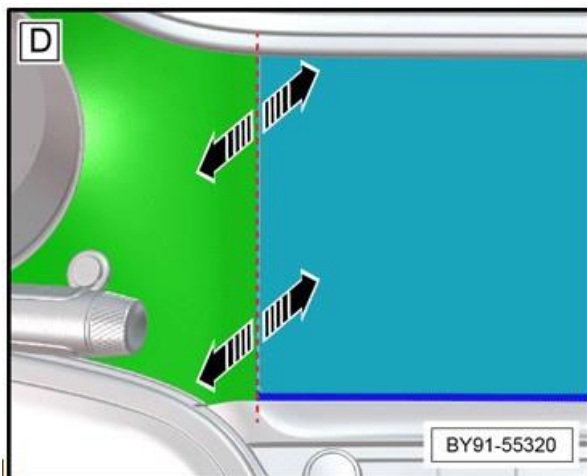
Measure the profile (D) between the “BRD” veneer face fascia panel and the passenger and drivers side fascia panels. See Figure 12

The specified setting dimension for the “BRD” fascia panel is -0.5mm (under flush) +/- 0.5mm tolerance and MUST be equal on both sides.

If either of the passenger and drivers side fascia panels are out of tolerance and require adjustment, make a note of which point requires adjustment and by how much on each panel.

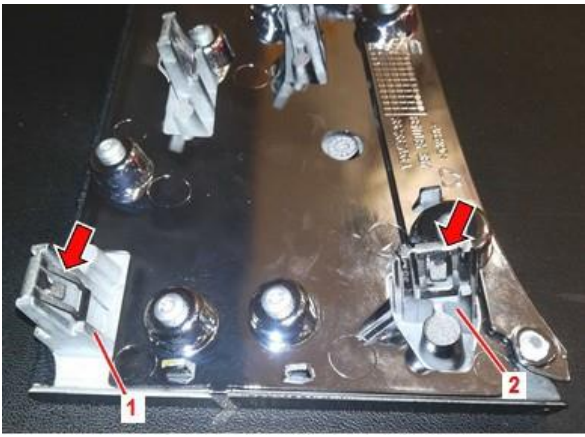
Figure 13

i Note. The locator pin (1) is for adjustment the top of the fascia panel and locator pin (2) is for adjusting the bottom of the fascia panel. All other locator pins are not affected.

With the fascia panel face down on a soft, clean and protective work surface, remove the appropriate spring clip(s) (arrow) as required. See Figure 13.

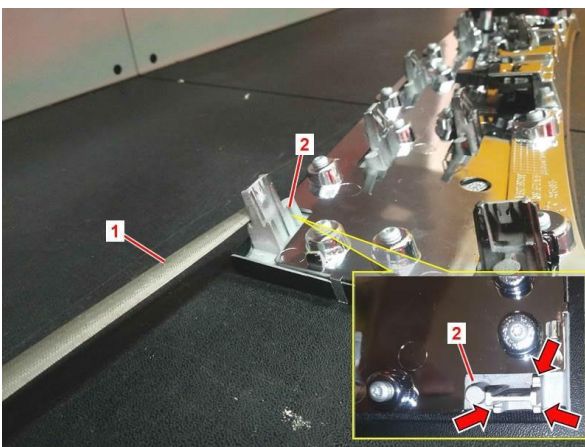
Figure 14

i Note. The upper locator pin (2) has three "RPS" points (arrows) whereas the lower locator pin only has two "RPS" points.

Carefully file the "RPS" points (arrows) by the required amount that the fascia panel needs to move in.

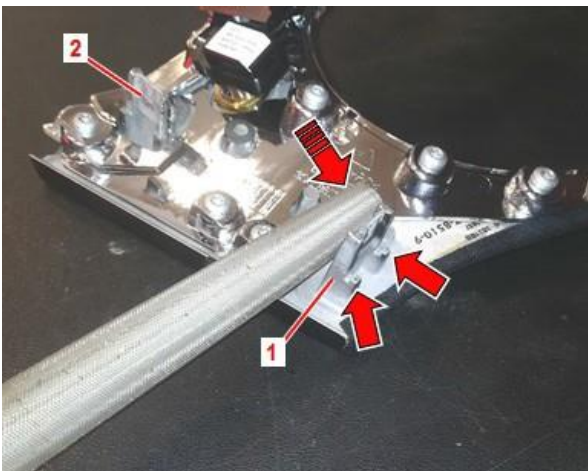
i Note. The upper locator pin (1) has three “RPS” points (arrows) whereas the lower locator pin (2) only has two “RPS” points.

Carefully file the “RPS” points (arrows) by the required amount that the fascia panel needs to move in. See Figure 17
