MODEL  
2019-2020MY  
Sedona (YP)

NUMBER  
194 (Rev 3, 03/05/2020)

SUBJECT: **SERVICE ACTION: TAILGATE GAS LIFT INSPECTION  
AND/OR REPLACEMENT (SA398)**

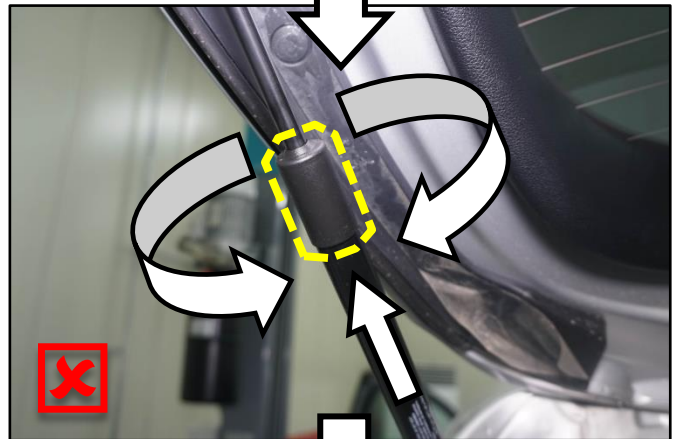
2. Inspect both of the tailgate gas lift dust covers (B) for the following failures:

- Unable to turn/rotate
- Slide upward
- Visual cracks

If any of the above conditions are present, refer to stop 3 and replace the affected tailgate gas lift(s).
