MODEL
2020MY
Telluride (ON)

NUMBER
199

TECHNICAL SERVICE BULLETIN

REAR WASHER NOZZLE IMPROVEMENT

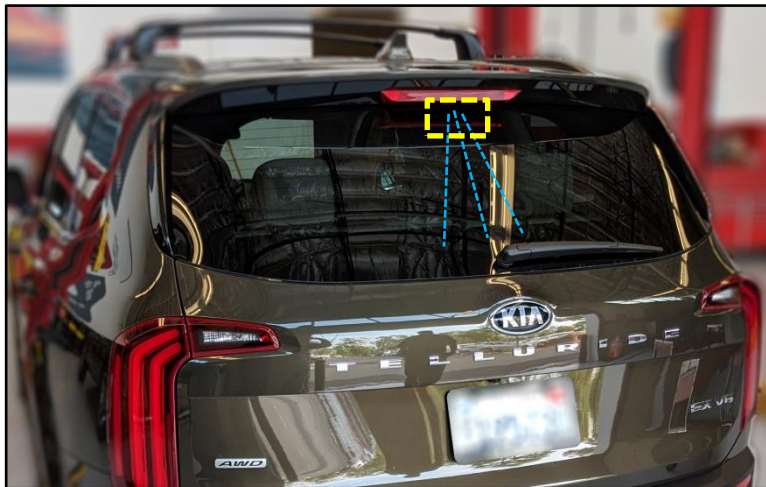
This bulletin provides the procedure to install an in-line washer fluid check valve on some 2020MY Telluride (ON) vehicles produced from April 1, 2019 through October 28, 2019, in order to improve a condition where the rear glass washer nozzle may leak after use. Follow the procedure outlined in this bulletin to install the in-line check valve to decrease washer fluid leaking from the rear nozzle.
