Service Alert

DTC C1001:92 OR B14F0:92 FORWARD SENSING CAMERA

Service Alert No.: SA-037/20

Last Issued: 03/03/2020

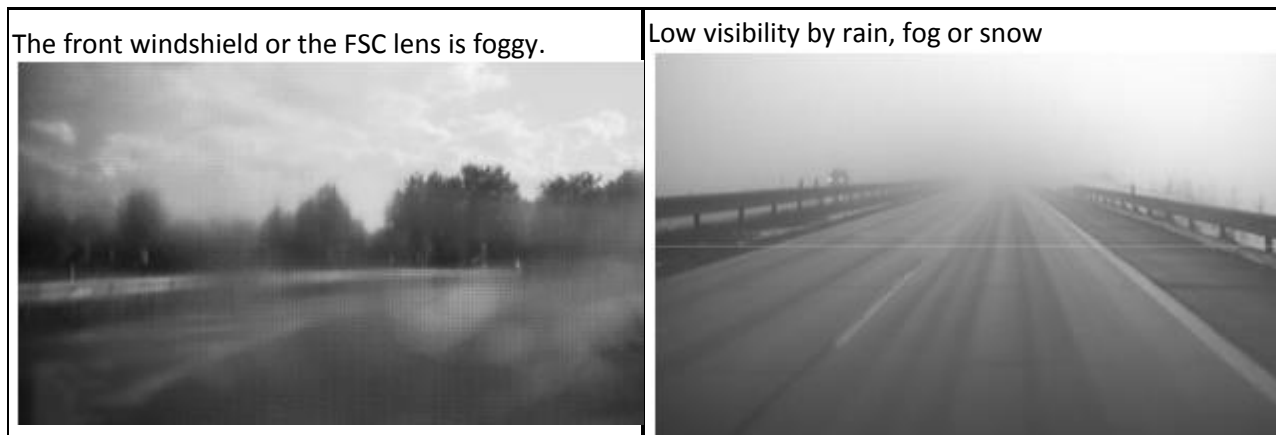
Examples of driving under adverse conditions:

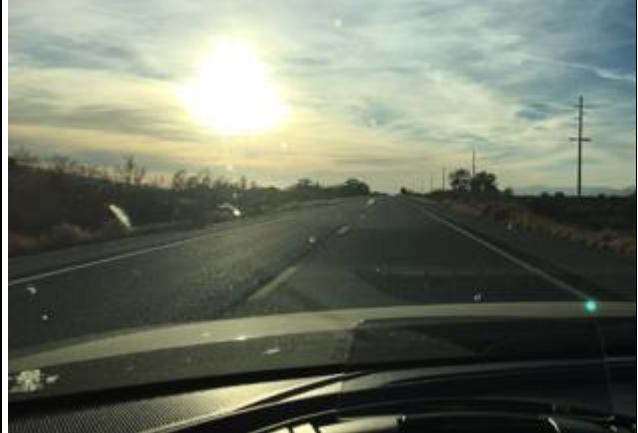
Direct or reflected sunlight on the FSC

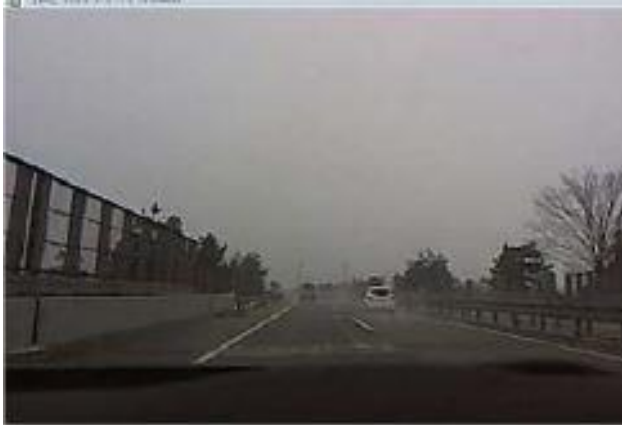
Water splashing

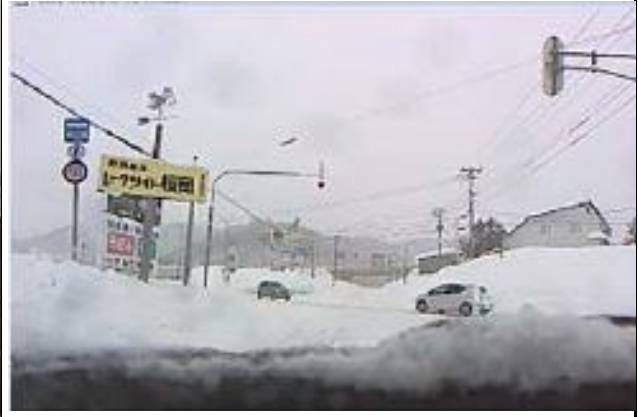
Heavy snow

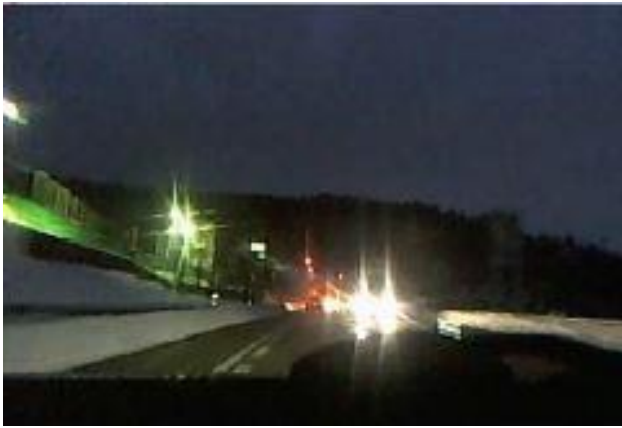
Strong halo

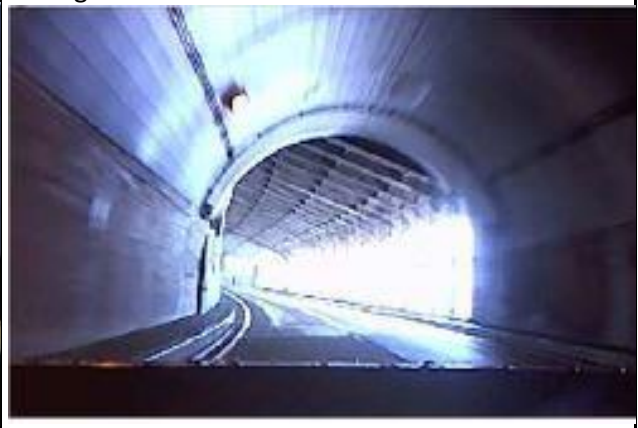
Backlight from tunnel exit
