Service Alert

MAZDA CONNECT CLOCK SHOWS INCORRECT TIME

Service Alert No.: SA-041/20

Last Issued: 03/11/2020

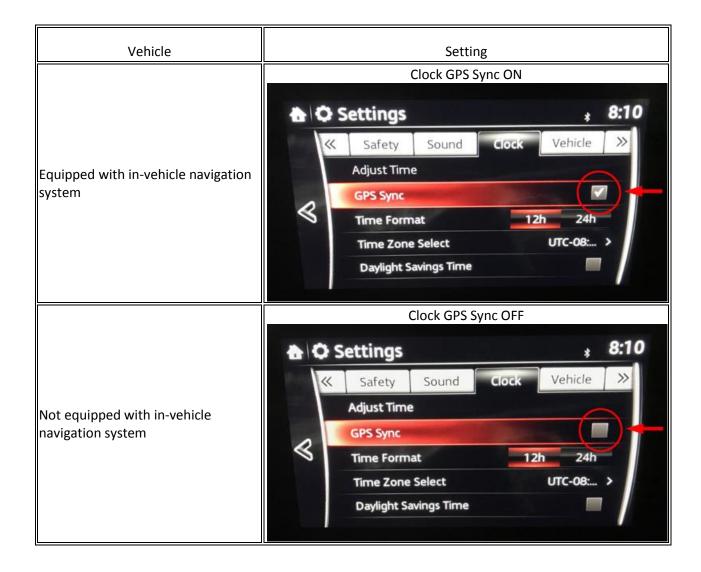
Some customers may complain about incorrect MAZDA CONNECT clock time. This may be caused by an incorrect clock GPS Sync setting.

Note: If clock GPS Sync is ON and vehicle is started with no view of the sky, clock may be inaccurate momentarily.

Clock accuracy can be improved using the following settings:
