STAR ONLINE PUBLICATION

Case Number: S20190000001

Symptom/Vehicle Issue: U11E8-00-LOST COMMUNICATION WITH EPS STEERING TORQUE MESSAGE

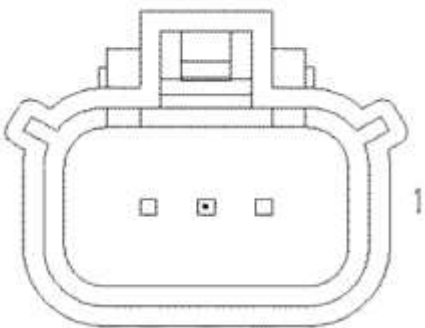
[End View](#)

Discussion: Inspect the EPS Jumper Circuit F914 at the headlamp/dash harness side, inline connector XY211 for broken or stressed wires. Inspect pins for pushout. Defect can be from the back of the connector throughout the exposed area. If no damages are found, check along other areas of the circuit for breaks or rubbing. If no issue found, check for continuity/resistance of the EPS Jumper harness.

Note- It is unlikely that the **EPS Gear** is the cause of the fault code. Diagnose wiring or other modules before replacing the gear.

Full Repair Kit: 68358151AA
