STAR ONLINE PUBLICATION

Case Number: S2005000002

Symptom/Vehicle Issue: Pad Contact On Rotor After Brake Service

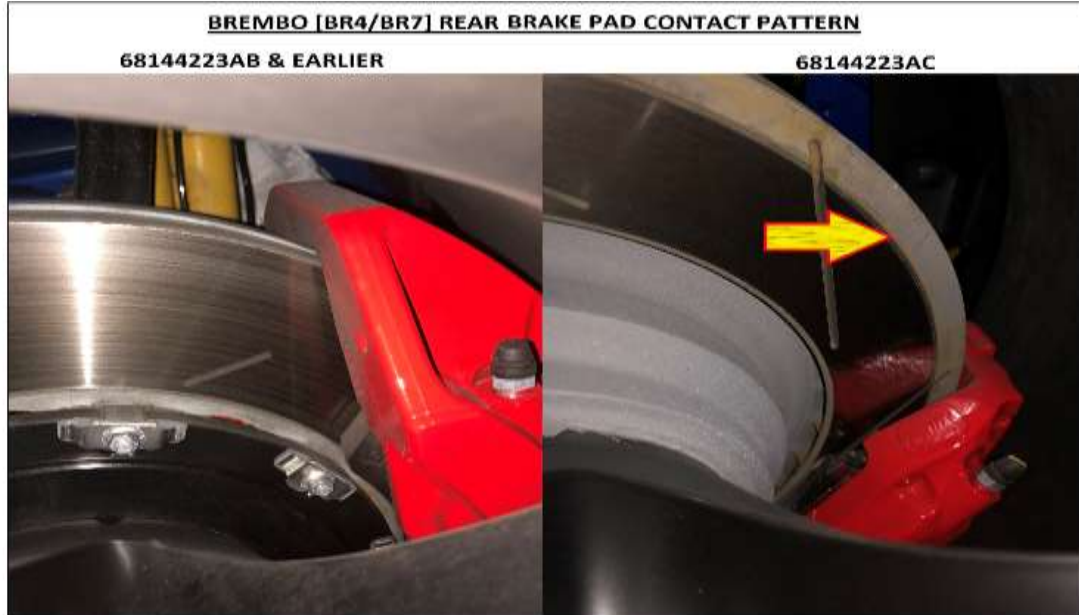
Discussion: Customers may notice a difference in the wear area on the rotor surface after a brake pad change. The SRT brake packages for BR4 and BR7 have been updated to a new “J” shaped pad to reduce noise complaints. This pad change will have a different contact area on the rotor. This is normal. See images below.
