## **STAR Case**

Case Number: S1723000001

**Symptom/Vehicle Issue:** Left Hand Drivers Side Mirror Takes Longer to Defrost Or Clear Than Right Side Passenger

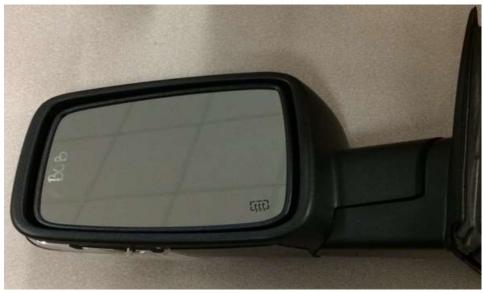
**Discussion:** The driver's side or left side door mirror is an ElectroChromic (EC) dimming mirror. The passenger side is not an EC mirror. Having the EC coating on the driver's side mirror does lengthen the time it will take to defrost or clear the mirror when compared to the right side. This is a normal condition and not a part failure. Replacing the mirror(s) will not correct this.
