STAR ONLINE PUBLICATION

Case Number: S2023000010

Symptom/Vehicle Issue: Power Lift Gate Opens 1 To 2 Feet Then Closes

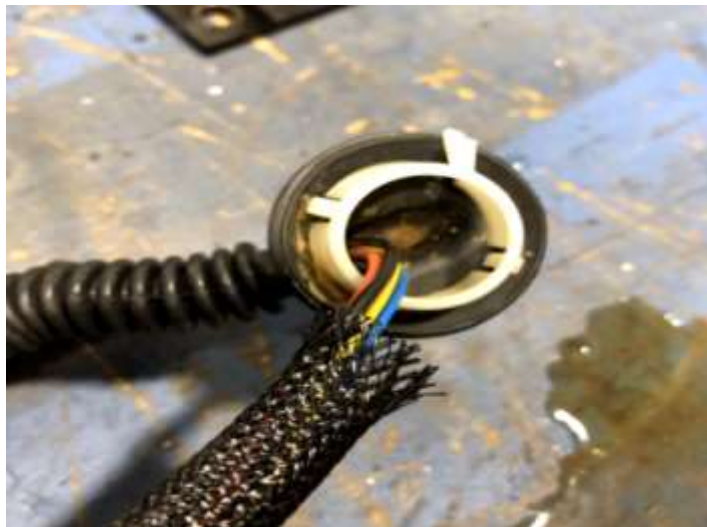
Discussion: An intermittent power lift gate operation complaint could be due to water intrusion in the gate harness. Inspect the pass-through grommet at the top of the lift gate for being fully seated. If found not seated- inspect inside the grommet and gate for signs of water. Water could track down the harness and enter the power lift gate prop assembly. If there is water in the power lift gate prop replace it and the harness.

Water inside the body to lift gate harness grommet
