STAR ONLINE PUBLICATION

Case Number: S1908000022

Symptom/Vehicle Issue: Navigation Search Feature Does Not Work

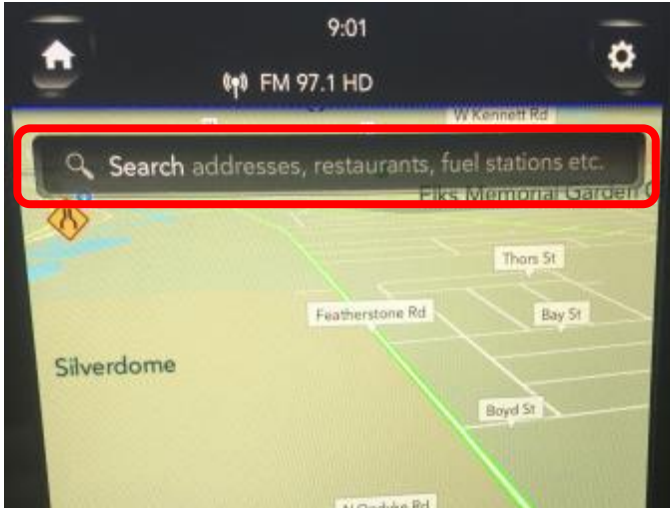
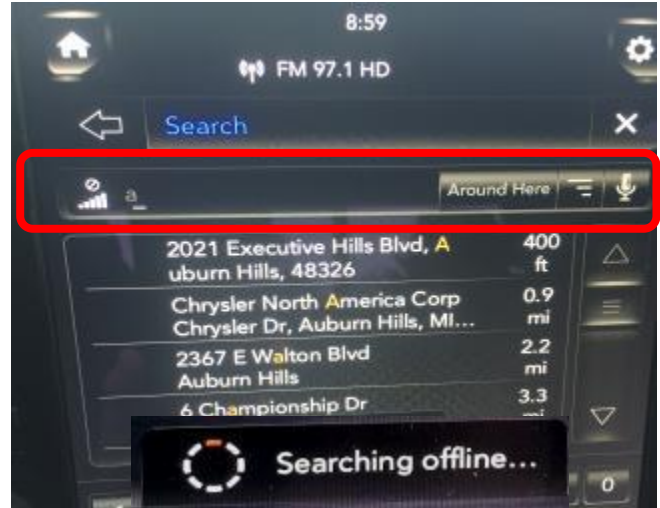
If the customer does not have a Sirius Guardian subscription, the radio will not be “online” and will show a message “**Searching Offline**” after initiating a search.

Resulting messages may include “Invalid Search” or “No Matching Results”.

These messages are per design since the VIN may not be registered on the Sirius XM server for the feature. See photos below.

Repair: DO NOT REPLACE THE RADIO for this symptom. Function is not fully operational without proper registration with Sirius XM. User can enter an address through the steering wheel voice recognition button or the Navigation menu buttons.

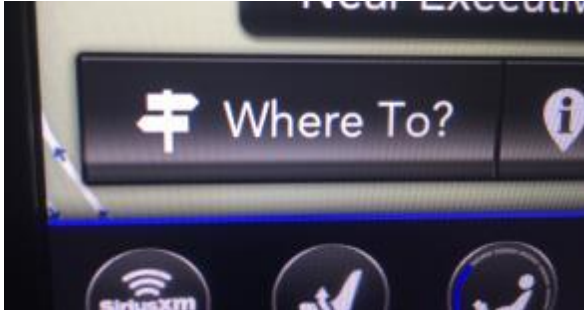
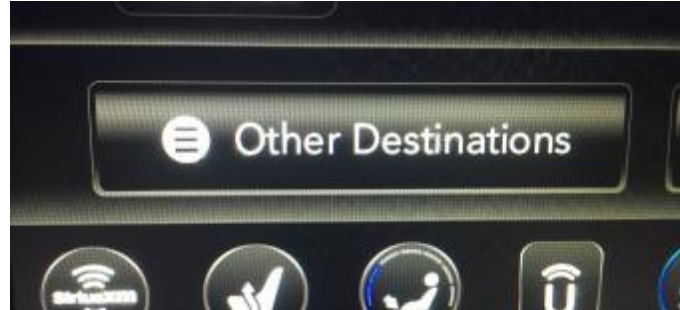
Enter address through Navigation menu buttons, press “Where To?”

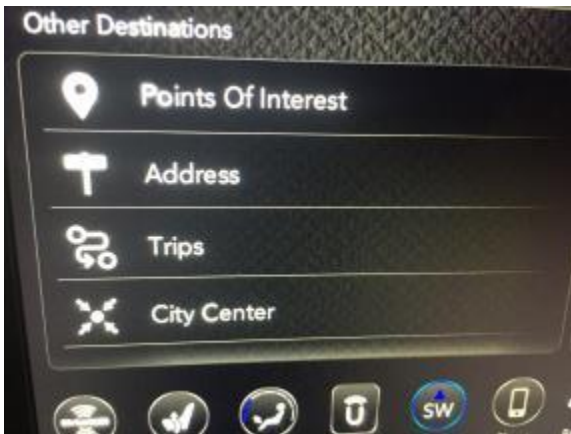
Enter address through Steering Wheel VR button
