**UPDATE FROM WARRANTY OPERATIONS**

**FIXED FIRST VISIT IMPROVEMENT**

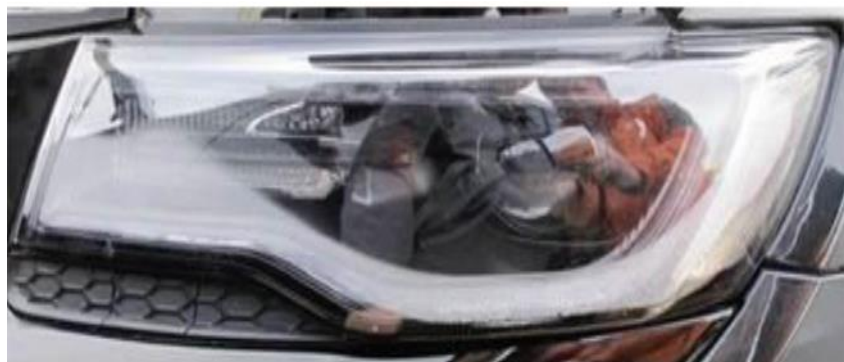
If the condensation/fogging has begun to clear from the lamp lens after 20 minutes with the lamps operating, this indicates the lamp sealing has not been breached, and the lamp does not need to be replaced. (see below)

Condensation Fogging - Do Not Replace

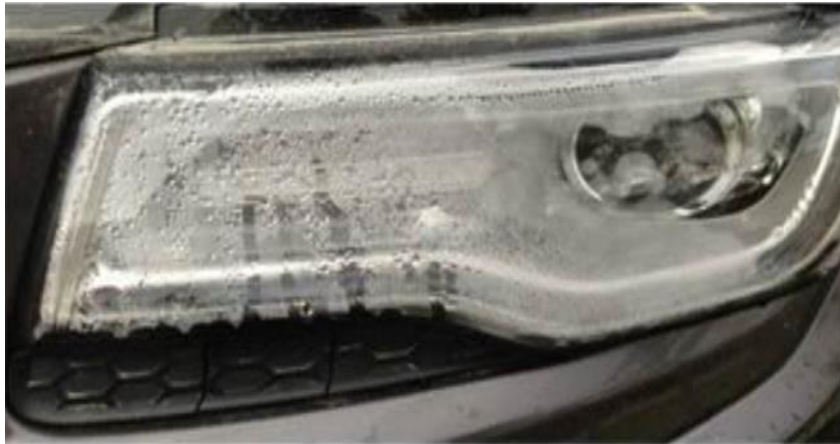
If the condensation/fogging has not begun to clear after 20 minutes with the lamps operating, or the lamp has large amounts of water droplets visible on most internal surfaces, this indicates an issue with the lamp sealing that has allowed

water to enter the lamp. In this instance, the customer is also likely to report that moisture in the lamp is always present and never disappears. A lamp that exhibits internal moisture permanently should be replaced.

Heavy Water Droplets – Replace

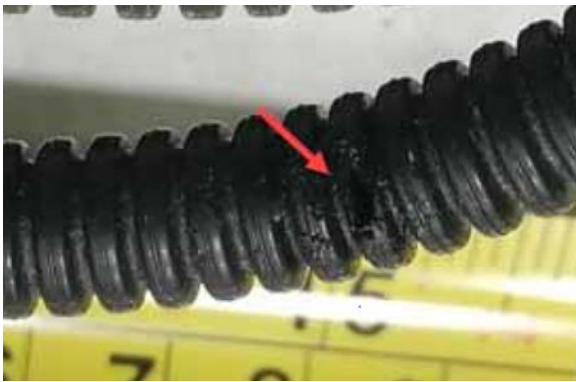
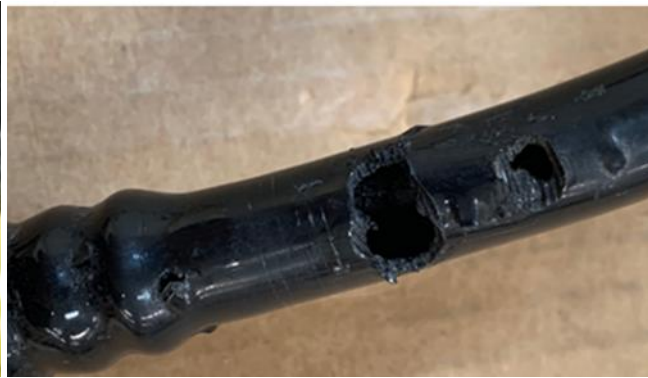
If a vehicle is found to have leakage (i.e. small EVAP leakage, liquid, or air flow) due to a part being damaged from apparent chewing on the line, the Customer must be told that this is not a warrantable concern. Damages caused in this manner are not considered a Defect in Material

or Workmanship and as such, may not be filed as a warranty claim. Examples of Warranty returned vapor hoses with non-warrantable damage are shown below. The vehicles had an engine light on, and DTC P0456 (small EVAP leakage) or P0455 (large EVAP leakage).

Damage such as above could be considered for Consumer Goodwill by adding the 85-85-CG-09 LOP as a related LOP to the condition. For further guidelines on the use of that Labor Operation, please see Warranty Bulletin D-17-18

Rev. A released on May 2, 2018. Any warranty claims submitted, without the use of the Consumer Goodwill Labor Operation number, with this type of damage will be charged back.

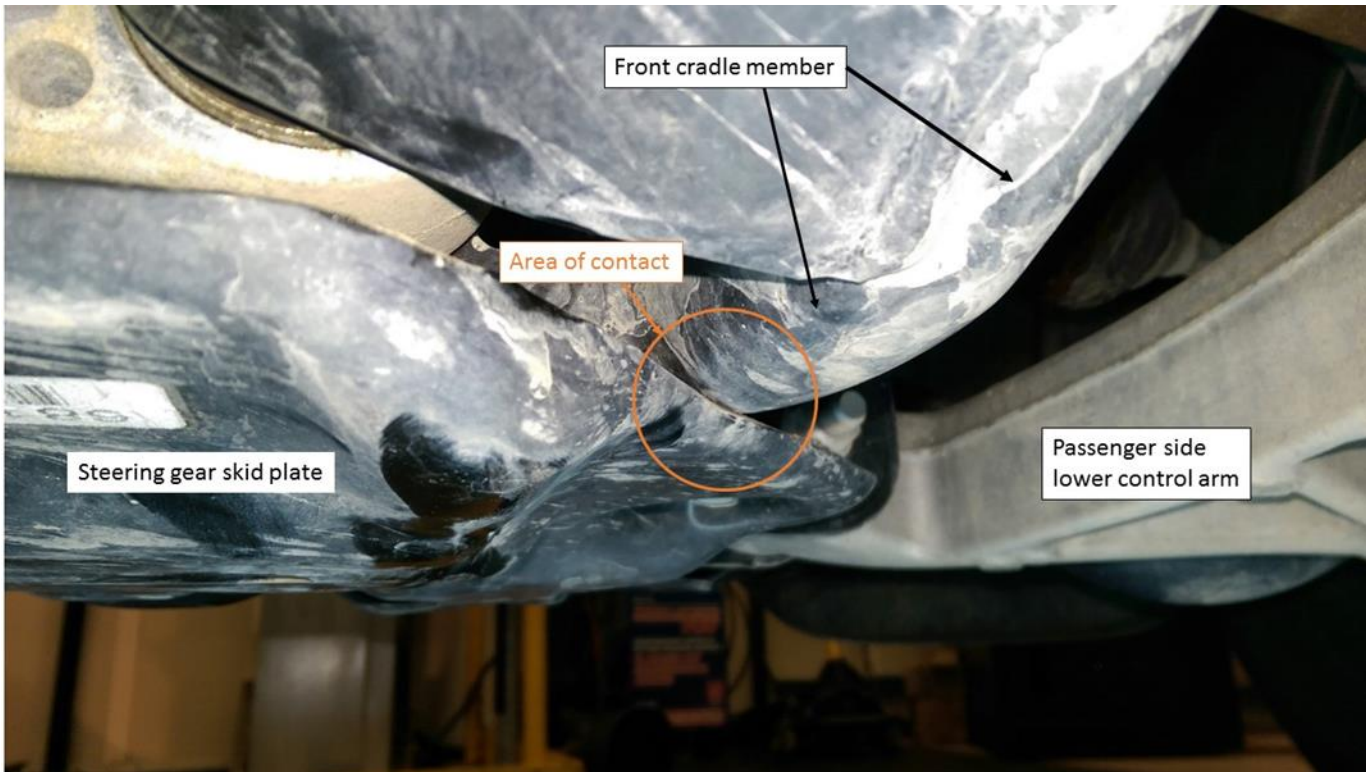
On vehicles built prior to April 15, 2019, if you experience a front suspension creak, or pop at low speed when going up a driveway, or driving over bumps in the road, that sounds like a sway bar bushing or a control arm bushing, be sure to check if the steering gear skid plate is contacting the front suspension cradle. The skid plate should be 5mm away from the right side cradle arm. We have found that in many

cases control arms or sway bars are being replaced in an attempt to correct this issue, when actually the skid plate is contacting the cradle arm and causing the sound to travel into the cradle. Simply creating the necessary 5mm clearance will correct this issue. Control arms or sway bars should not be replaced to correct this noise issue. See the picture below.
