NUMBER: 08-014-20

Body Control Module (BCM) Reconfigure for Enabling the Auto-On Comfort Settings

2019 - 2020 (DT) RAM 1500 Pickup

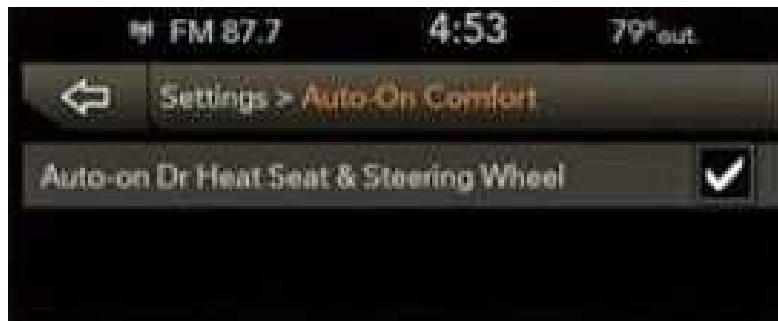
Fig. 1
Auto-On Comfort Screen

7. Is there a setting with single check mark to enable or disable the “Auto-On Comfort” feature ([Fig. 1](#)) ?
 - YES>>> This bulletin has been completed, use LOP (18-19-02-EW) to close the bulletin.

8. Perform a **radio reset** using wiTECH “Guided Diagnostics/Reset ECU”.
9. Place the ignition in the off position, disconnect the wiTECH MicroPod and open and close the driver door. This will allow all modules to go to sleep and should take about one minute.
10. Verify the “Auto-On Comfort” feature by going into the radio “Settings>Auto-On Comfort”.
11. Is there a setting with single check mark to enable or disable the “Auto-On Comfort” feature ([Fig. 1](#)) ?
 - YES>>> This bulletin has been completed, use LOP (18-19-02-EW) to close the bulletin.
 - NO>>> Further diagnosis should be performed.
