**NUMBER:** 08-016-20

Body Control Module (BCM) Reconfigure for Enabling the Auto-On Comfort Settings

2018 - 2020	(WK)	Jeep Grand Cherokee
2018	(W2)	Jeep Grand Cherokee (Venezuela)
2018 - 2019	(W3)	Jeep Grand Cherokee (Egypt)

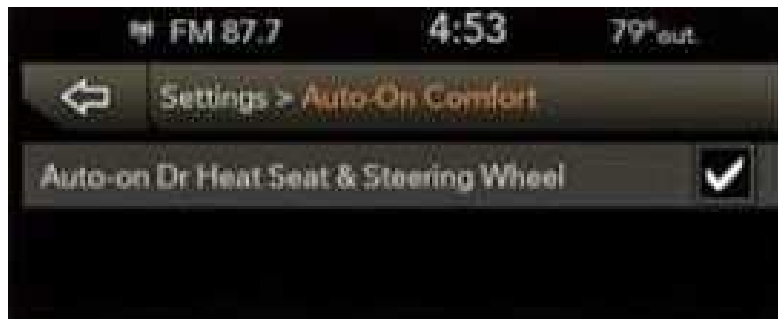
**Fig. 1**  
**Auto-On Comfort Screen**

7. Is there a setting with single check mark to enable or disable the “Auto-On Comfort” feature ([Fig. 1](#)) ?
  - YES>>> This bulletin has been completed, use LOP (18-19-02-EX) to close the bulletin.

8. Perform a **radio reset** using wiTECH “Guided Diagnostics/Reset ECU”.
9. Place the ignition in the off position, disconnect the wiTECH MicroPod and open and close the driver door. This will allow all modules to go to sleep and should take about one minute.
10. Verify the “Auto-On Comfort” feature by going into the radio “Settings>Auto-On Comfort”.
11. Is there a setting with single check mark to enable or disable the “Auto-On Comfort” feature ([Fig. 1](#)) ?
  - YES>>> This bulletin has been completed, use LOP (18-19-02-EY) to close the bulletin.
  - NO>>> Further diagnosis should be performed.
