**NUMBER:** 08-019-20

Body Control Module (BCM) Reconfigure for Enabling the Auto-On Comfort Settings

2018 - 2020

Dodge Durango

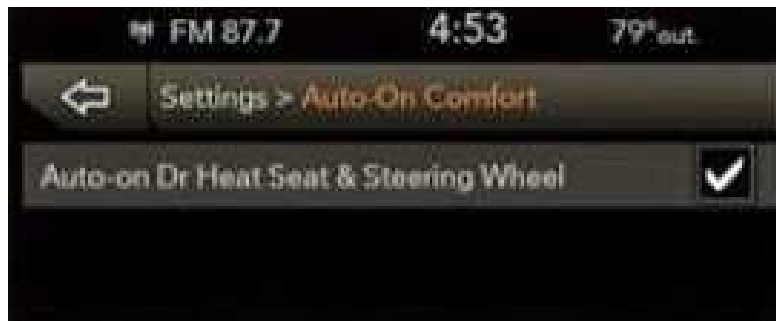
**Fig. 1**  
**Auto-On Comfort Screen**

7. Is there a setting with single check mark to enable or disable the “Auto-On Comfort” feature ([Fig. 1](#)) ?
  - YES>>> This bulletin has been completed, use LOP (18-19-02-FA) to close the bulletin.

8. Perform a **radio reset** using wiTECH which can be found in “Guided Diagnostics/Reset ECU”.
9. Place the ignition in the off position, disconnect the wiTECH MicroPod and open and close the driver door. This will allow all modules to go to sleep and should take about one minute.
10. Verify the “Auto-On Comfort” feature by going into the radio “Settings>Auto-On Comfort”.
11. Is there a setting with single check mark to enable or disable the “Auto-On Comfort” feature ([Fig. 1](#)) ?
  - YES>>> This bulletin has been completed, use LOP (18-19-02-FB) to close the bulletin.
  - NO>>> Further diagnosis should be performed.
