**NUMBER:** 23-008-20

**DATE:** February 12, 2020

Incorrect Front License Plate Bracket

2019 - 2020 (LA) Dodge Challenger

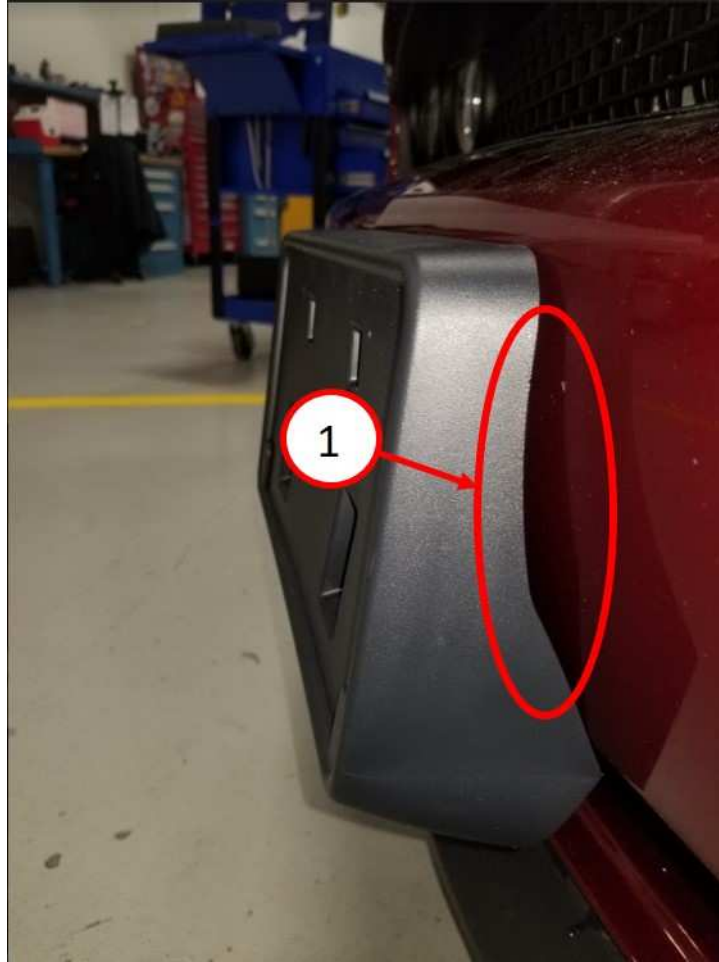
**Fig. 1**

- A large gap can be seen on the sides of the license plate bracket.

2. Is the gap larger than 2 mm (1/8 inch)(Fig. 1) ?

**Gap Between License Plate Bracket and Bumper Cover (Example of Bad Fitment Shown)**

1 - Area To Measure Between Front Bumper Cover and License Plate Bracket.

1. Replace the front license plate bracket.
