**NUMBER:** 23-009-20

Loud Scraping or Clunking Noise From the Front Suspension

2020 (JT) Jeep Gladiator

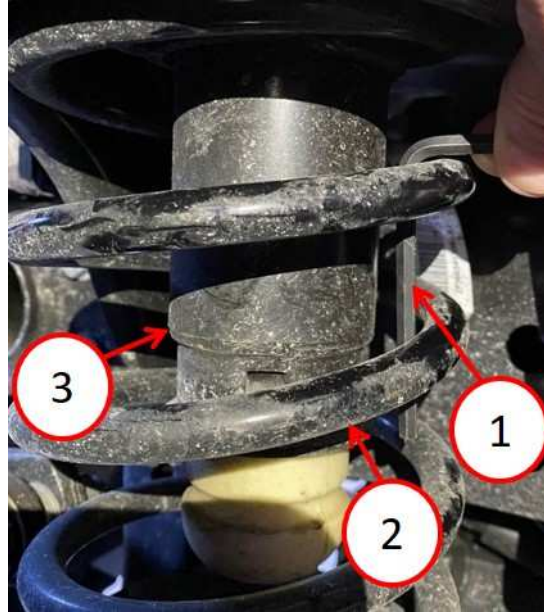
Fig. 1

Insert the Allen wrench between the bow and the jounce cup inside the coil spring (Fig. 1) . **The Allen wrench should be able to pass completely around the coil spring bow without touching the jounce cup (Fig. 2) .**

**Checking Clearance Between The Spring Bow And Jounce Cup**

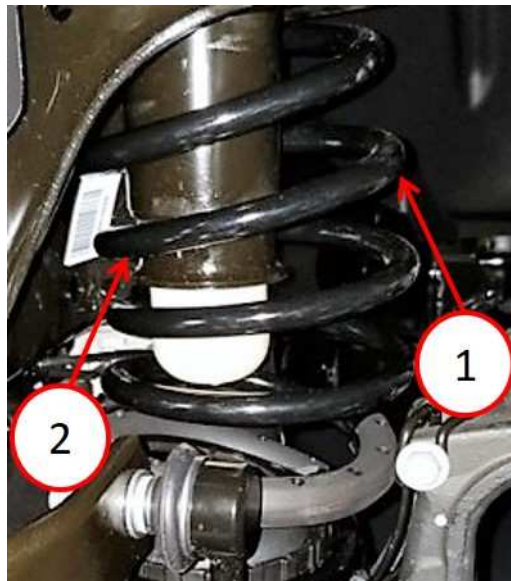
Fig. 2

**Defective Coil Spring**

- 1 - Badly Bowed Coil Spring
- 2 - Coil Spring Touching Or Too Close To Jounce Cup

2. Is the clearance between the spring bow and jounce cup less than 5 mm (0.5 cm)?
- YES>>> Replace the coil spring. Proceed to [Step 1](#) of the Repair Procedure.
  - NO>>> This bulletin has been completed, use LOP (02-27-01-9C) to close the active RRT.

- Both front coil springs do not need to be replaced for this Repair Procedure. Only replace the Left for (Sales Code ZAC) or the Right for (Sales Code ZNC) front inner coil spring with the symptom/condition above.
  - When replacing a coil spring, check that the upper isolator is properly seated in the frame spring seat. Also confirm the spring is properly seated in the lower isolator to ensure a complete repair.
1. Replace the coil spring. Refer to the detailed service procedures available in DealerCONNECT/ Service Library under: Service Info>02 - Front Suspension/Front/Spring, Front Coil/Removal and Installation.
