NUMBER: 23-010-20

GROUP: 23 - Body

Sunroof Water Leak

This bulletin involves testing the sunroof for leaks and replacing the power sunroof glass if necessary.

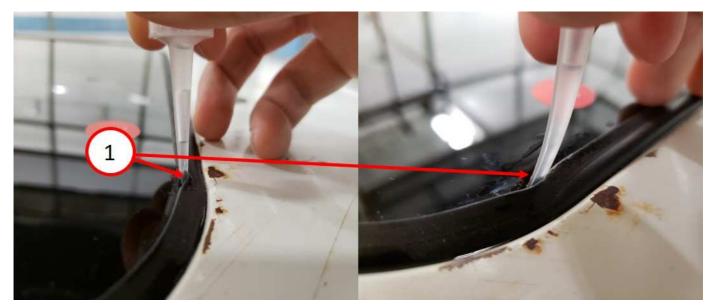
Fig. 4 Seal Testing

5. Insert syringe tip between sunroof glass and seal along side of glass at beginning of front corner tangent. Press on plunger to begin injecting water and empty entire volume over several seconds (Fig. 4).

NOTE: DO NOT insert syringe tip between seal and body.

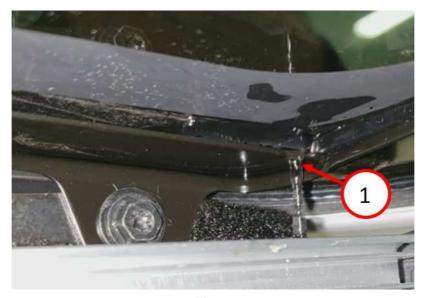
Fig. 5
Example of Water Leak

The customer may describe a water leak from A-pillar grab handle or headliner microphone.

6. While water is being injected have assistant inspect for water leaking from the sunroof glass frame near front glass attachment (Fig. 5).

1 - Water Leak

Replace the sunroof glass. Refer to the detailed service procedures available in DealerCONNECT/Service Library under: Service Info 23 - Body / Sunroof / GLASS, Sunroof / Removal and Installation. -5- 23-010-20
