NUMBER: 08-024-20

Connected Services Including Mobile App Services - Inoperative

2019 - 2020 (MP) Jeep Compass

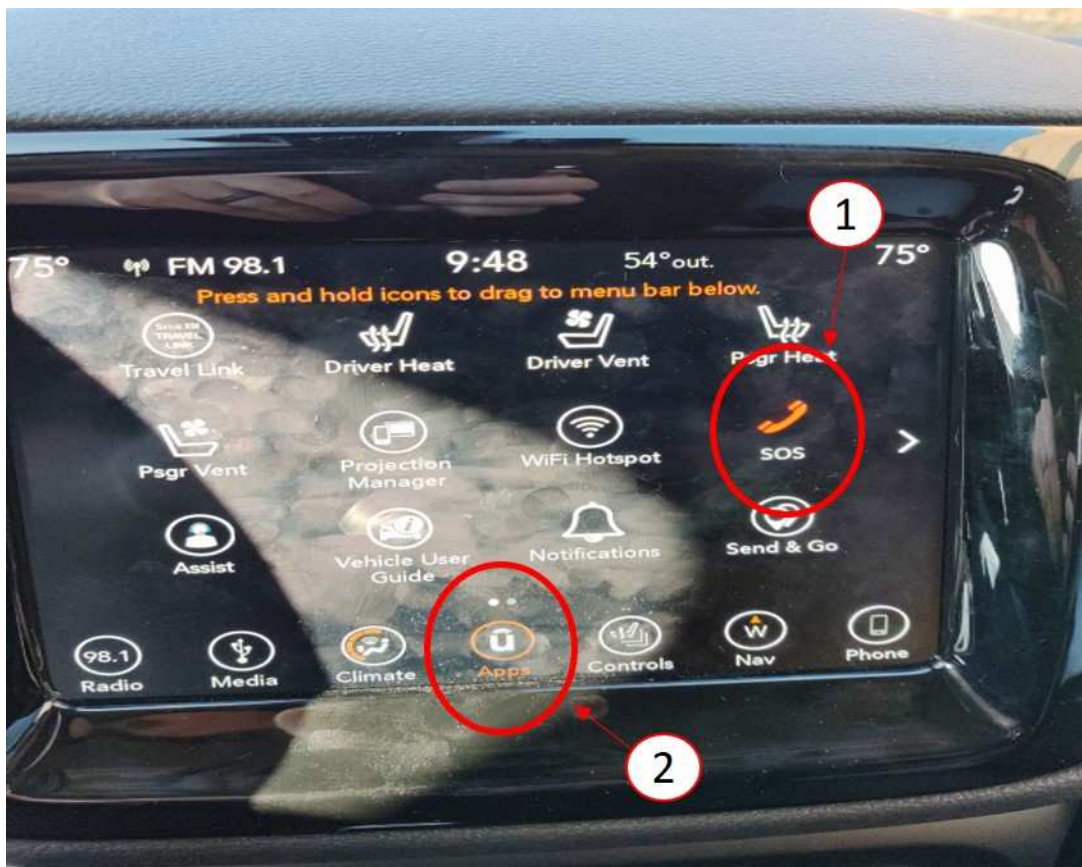
Fig. 1
SOS App

- 1 - SOS Icon
2 - Apps Icon

1. Using wiTECH, "Restore Vehicle Configuration". This routine is available under the "Guided Diagnostics" tab found on the home, "Vehicle View", page of wiTECH.
2. Perform a "Proxi Configuration Alignment" and follow all prompts:
 - a. Cycle the ignition OFF, unplug wiTECH pod and close the doors to let all modules go to sleep, wait two minutes.
 - b. Reconnect wiTECH.
 - c. Cycle the ignition "ON" again.
3. Using wiTECH, perform a Radio/ETM hard reset, return to "Guided Diagnostics". Select "Reset ECU", and follow screen prompts, then select "ETM". After the ETM reset completes, the Connected Services apps should now appear.
4. Clear any DTCs which may have been set during the proxi configuration procedure.
5. Confirm the repair by going into the "Apps" section of the radio, then confirm the "SOS" icon is present on one of the pages (Fig. 1) .
