# Service Bulletin

Bulletin No.: 18-NA-113

**Subject:** Hard To Fill, Fuel Filling Station Nozzle Shuts Off Early and/or Spitback During Filling

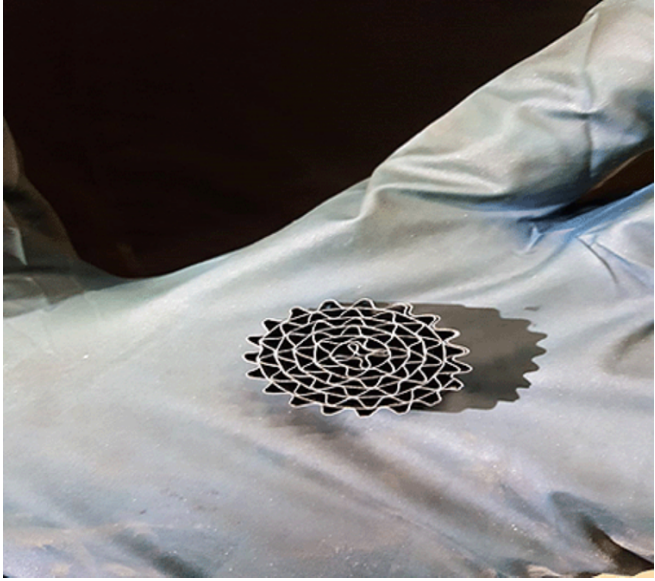
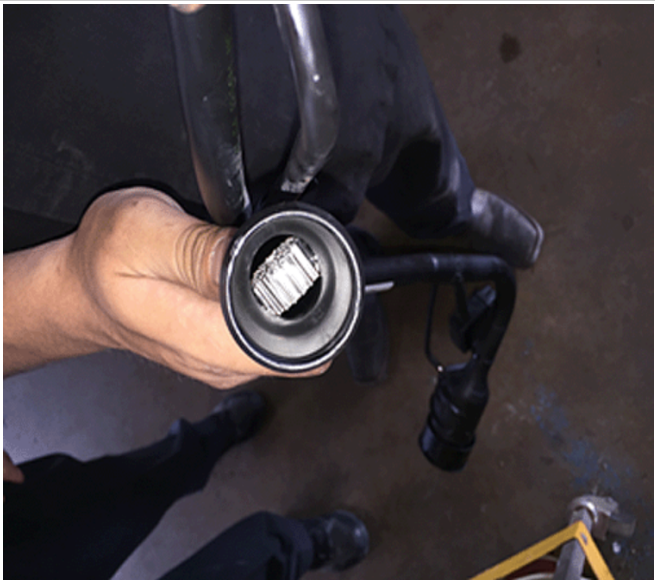
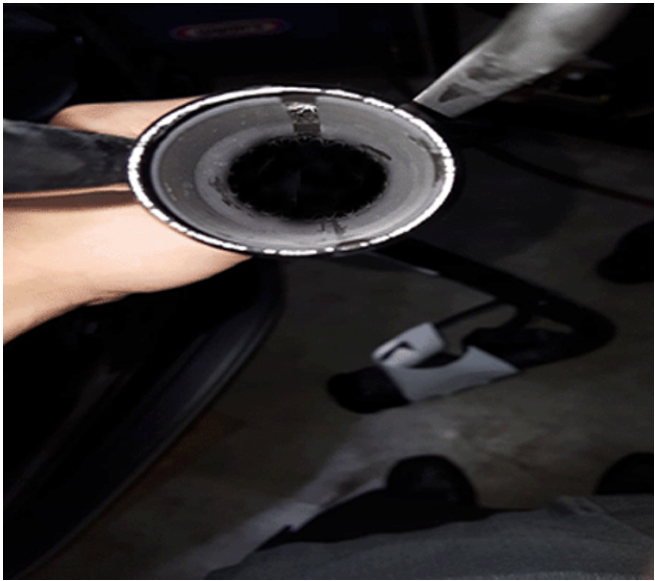
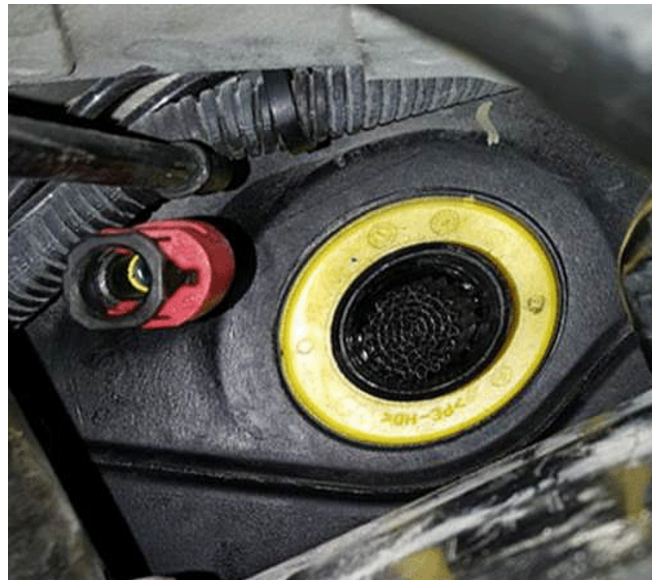
This condition may be caused by the vapor generation reduction device (VGRD) in the fuel pipe that may have become dislodged, moved out of position and/or stuck in the fuel tank inlet check valve, as shown above, and is restricting fuel flow.

If a restriction is located in the fuel filler pipe, or the generation reduction device is out of position, replace the fuel filler tube. Refer to *Fuel Tank Filler Pipe Replacement* in SI.

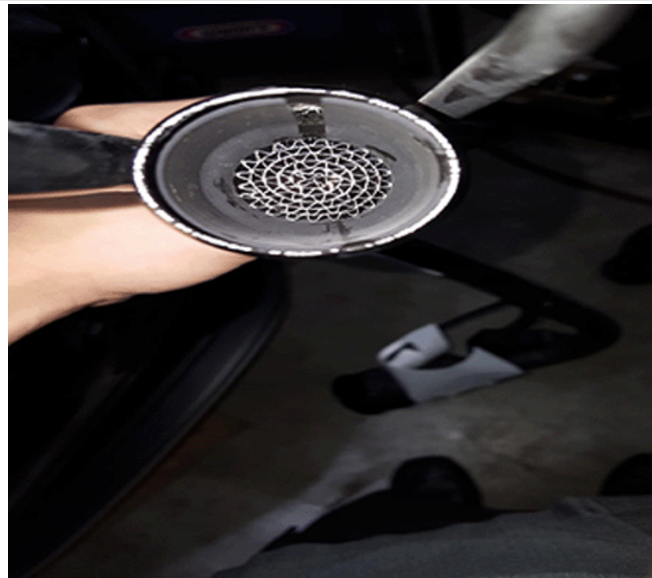
5034600

Identify if the vapor generation reduction device is out of position by inspecting the fuel filler tube. If the VGRD is in the correct installation orientation, as shown above, refer to *Poor Fuel Fill Quality* in SI for further diagnosis.
