Service Bulletin

Bulletin No.: 18-NA-114

Subject: Service All Wheel Drive (AWD)/Service Stability Messages Displayed on Driver Information Center (DIC), Erratic Speedometer Readings, Malfunction Indicator Lamp (MIL) Illuminated - DTC P0641, U0073, U0100, U0101, U0121, U0131 and/or U0136 Set

Brand:	Model:	Model Year:		VIN:		Engine:	Transmission:
		from	to	from	to		
Chevrolet	Trax	2018	2020			1.4L (LUV)

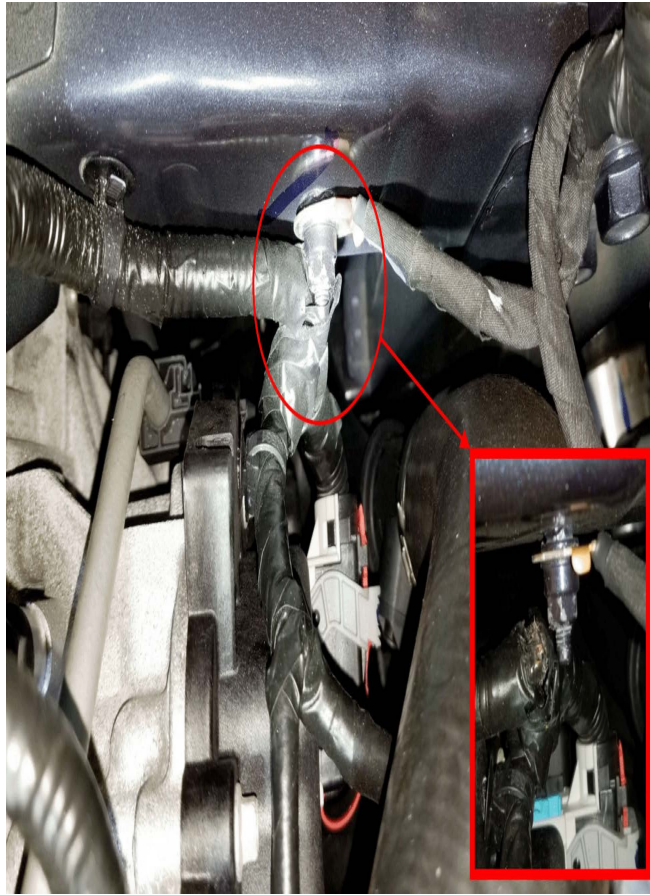
5040432

Cause	<p>Note: This is a multi-wire bundled harness and, depending on which wire is damaged, can set a variety of DTCs.</p> <p>This condition may be caused by the engine harness chaffing against the G100 Ground stud.</p>

If the above condition has been validated, inspection of the engine wiring harness must be done.

1. With a suitable light, inspect the wiring harness point of contact at the G100 ground stud.
- ⇒ For stud location, refer to Document ID: 4708510 in SI.
2. Repair the harness as needed.
- ⇒ Refer to *Wire to Wire Repair* in SI.
