# Service Bulletin

Bulletin No.: 18-NA-239

**Subject: Squeak, Rubbing and/or Grinding Type Noise Heard From Steering Wheel When Turning**

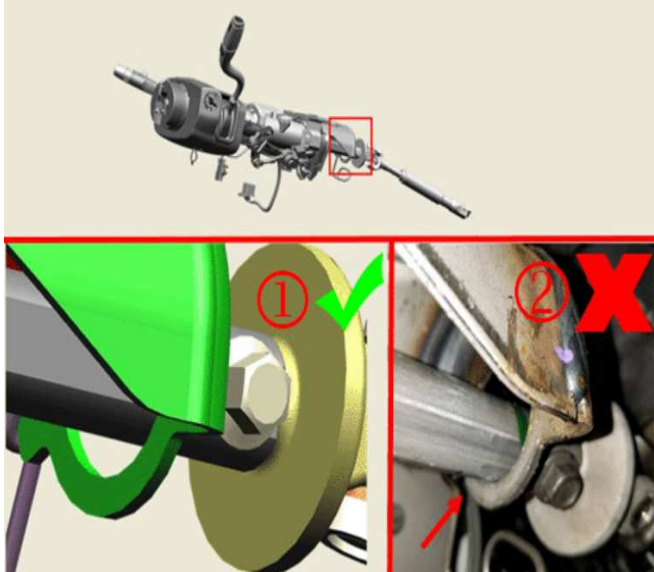
<b>Involved Region or Country</b>	North America and NA Export vehicles
<b>Additional Information</b>	Equipped with STEERING COLUMN-TILT TYPE (RPO N33)
<b>Condition</b>	Some customers may comment on a squeak, rubbing and/or grinding type noise heard from the steering wheel when turning.
<b>Cause</b>	This condition may be caused when the steering wheel is turned and the steering shaft is rubbing on the instrument panel (IP) support.

<p>5107122</p> <p>Shown in the illustration above is an example of a good part making no contact with the bracket (1), and a example of a bad part making contact (2).</p> <p>Inspect the steering column for coming in contact with the bracket to verify that the noise is the result of rubbing between the steering column and the bracket. Install washers on the upper column mounting bracket locations following the procedure below.</p> <p><b>Important: DO NOT</b> replace the steering column for this condition.</p>
-------------------	--
