# Service Bulletin

Bulletin No.: 18-NA-383

**Subject:** Water Found in Rear Interior of Cab, Water Leak at Rear Sliding Window

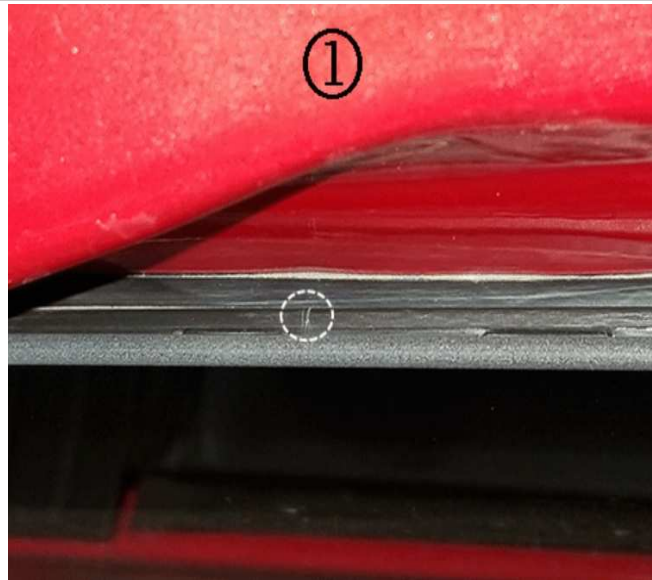
5201854

**Note:** The cracks can be in the left and/or right side of the rear sliding window plastic upper rail glass guide which is covered by the roof rear spoiler. Examples of a left (1), then right side (2) visual crack (with the spoiler removed) are shown in the graphics above.

The cause of the condition may be cracking in the rear sliding window plastic upper rail glass guide. The plastic upper rail glass guide may develop small fractures/cracking which allows water to pass through on the glass side of the urethane that attaches to the vehicle body.

R & R the roof rear spoiler and apply seam sealer to the rear sliding window top encapsulate, following the steps in the Service Procedure below.
