Service Bulletin

Bulletin No.: 19-NA-057

Date: February, 2020

Subject: Malfunction Indicator Lamp (MIL) Illuminated, DTC P0420 Set

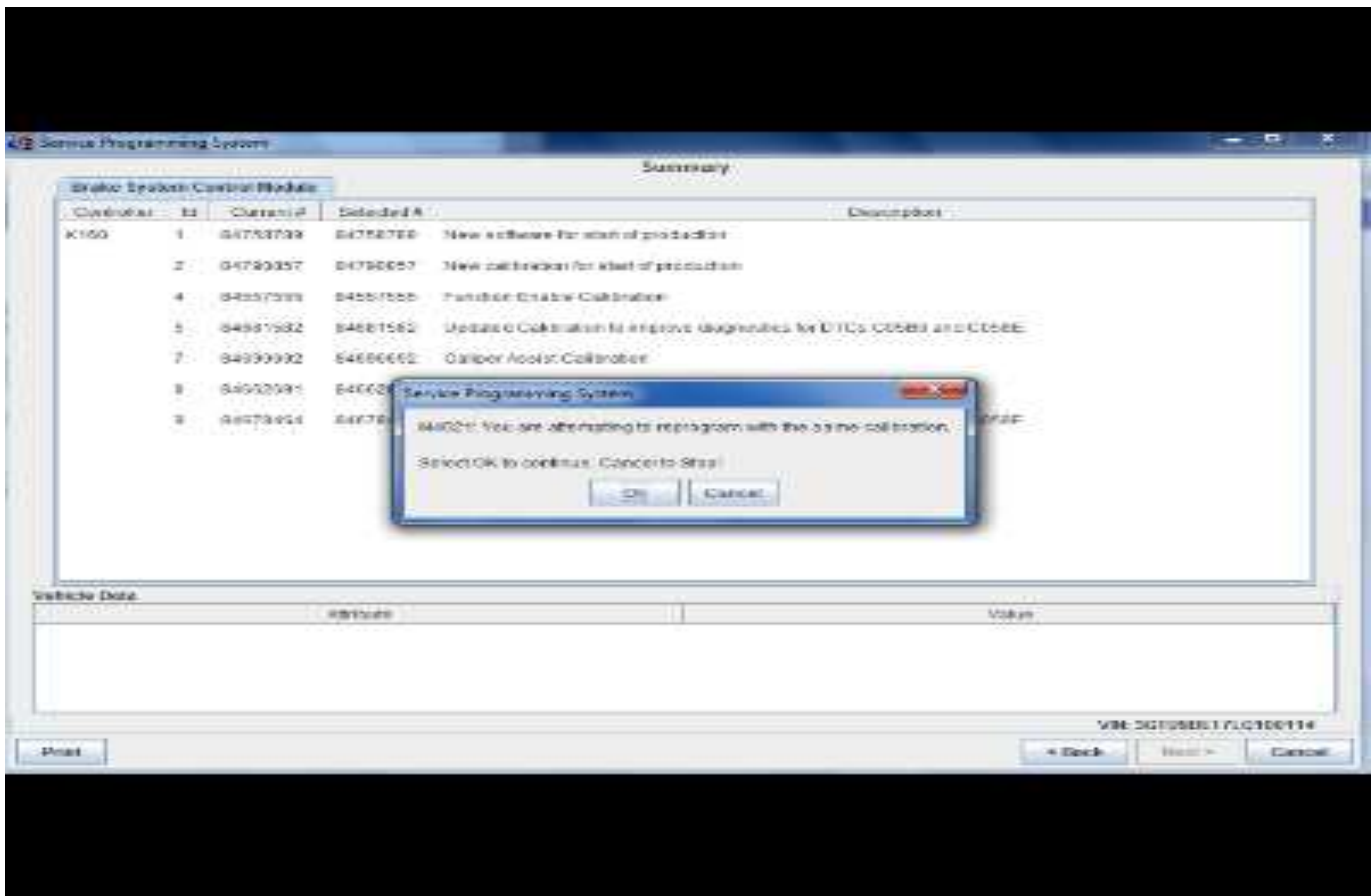
5431207

Important: If the Same Calibration/Software Warning is noted on the SPS screen, select OK and follow screen instructions. After a successful programming event, the WCC is located in the Service Programming System dialogue box of the SPS Summary screen. No further action is required. Refer to the Warranty section of the bulletin.

1. Reprogram the ECM and TCM modules. Refer to *Engine Control Module Reprogramming with SPS and Control Solenoid Valve and Transmission Control Module Assembly Programming and Setup* in SI. Modify as required (e.g., select x module from the controller screen. Then provide step-by-step instructions or refer to SI procedure.
