Service Bulletin

Bulletin No.: 19-NA-066

Subject: Missing Oil Filter Adapter Insert Causing Noise, Engine Failure After Oil Filter Was Changed, Malfunction Indicator Lamp (MIL) Illuminated

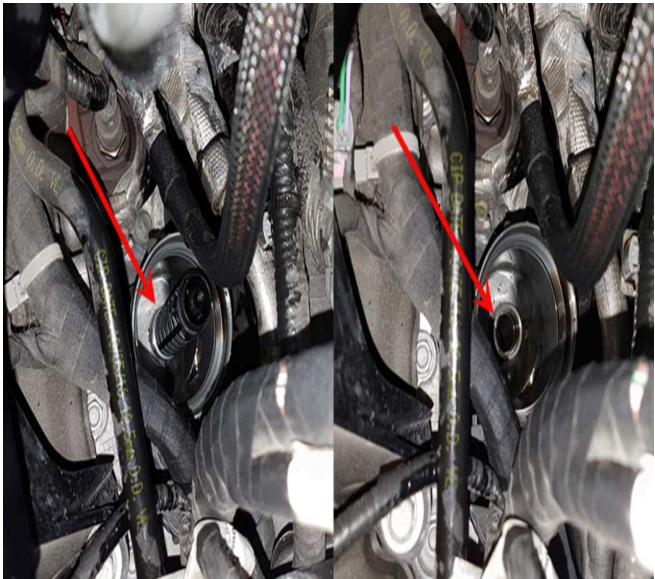
| Correction | <div style="text-align: center;"> </div> <p style="text-align: right; font-size: small;">5298102</p> <p>If a vehicle comes in with one of the conditions listed above, inspect the oil filter adapter to see if the center insert/bypass valve is missing.</p> |

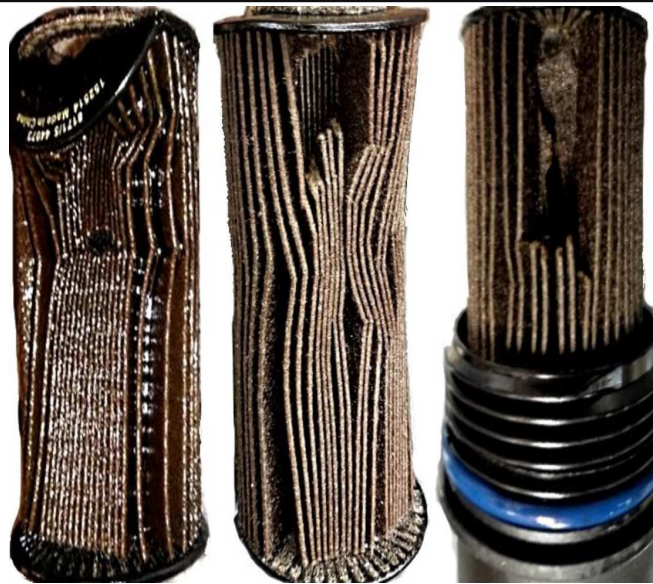
5297946

Note: Upon inspection, the technician may notice that the oil filter has been damaged or material from the oil filter may have been pushed into the oil galleries causing an upper engine noise.

If no mechanical damage has been found, inspect the oil filter for damage.

- ⇒ If there is paper debris, codes, and/or cam actuator noises, that does not require engine replacement, repair and/or replace the affected components and clean the engine thoroughly.
- ⇒ Order and install the oil filter adapter insert/bypass valve.
