# Service Bulletin

Bulletin No.: 19-NA-083

**Subject:** Creaking Type Noise Around Front Strut Mounts When Steering Wheel is Turned Right or Left in Colder Weather

| Brand: | Model: | Model Year: | | Breakpoint: | | Engine: | Transmission: |
|---|---|---|---|---|---|---|---|
| Chevrolet | Impala | 2014 | 2019 | - | - | - | - |

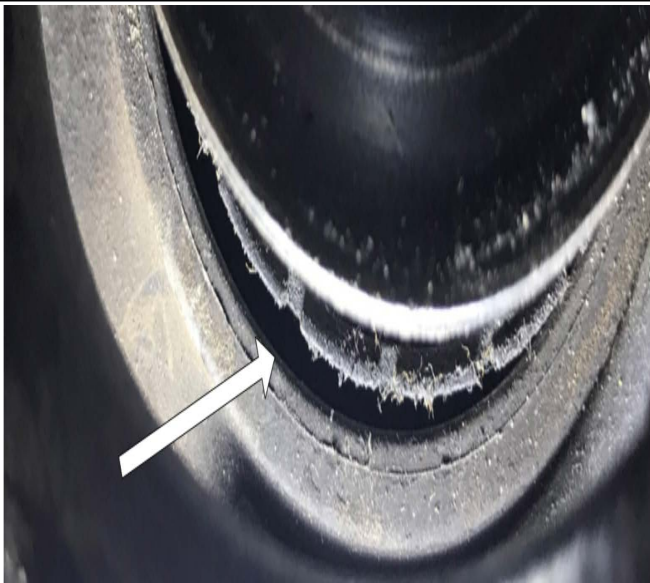
| Condition | Some customers may comment on a creaking type noise heard from the front strut mounts when the steering wheel is turned right or left in temperatures of 0°C (32°F) or colder. |
| Cause | <p>5315933</p> <p>This condition may be caused by a gap between the bearing lower housing and the top mount body.</p> |

| Correction | Replace both front strut mounts. Refer to <i>Strut</i> , <i>Strut Component</i> , or <i>Spring Replacement</i> in SI. |
