Service Bulletin

Bulletin No.: 19-NA-217

Subject: Manual Transmission Stalling, Clutch Chatter and/or Hard Shifting into 1st Gear or Reverse; Automatic Transmission Vibration on Launch and/or Engine Noise

Brand:	Model:	Model Year:		VIN Breakpoint		Engine:	Transmission:
		from	to	from	to		
Chevrolet	Corvette	2014	2019			6.2L (LT1, LT4)	6L80 Automatic (MYC), 8L90 Automatic (M5U) or Manual

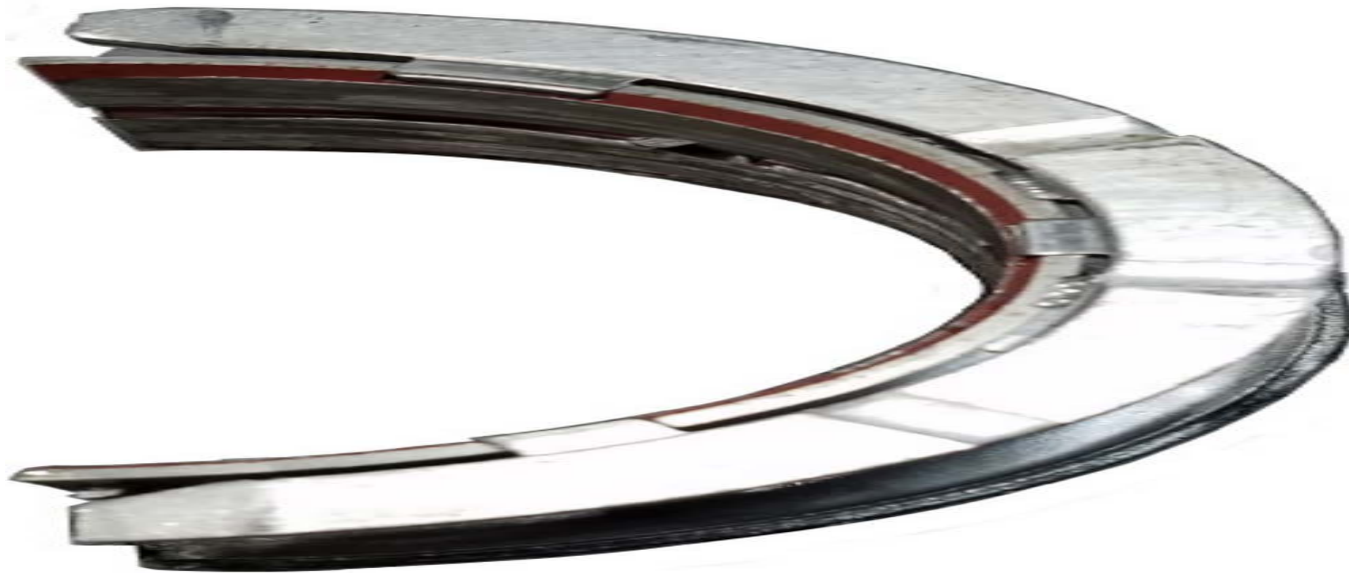
5403465

Example of a good thrust bearing face.

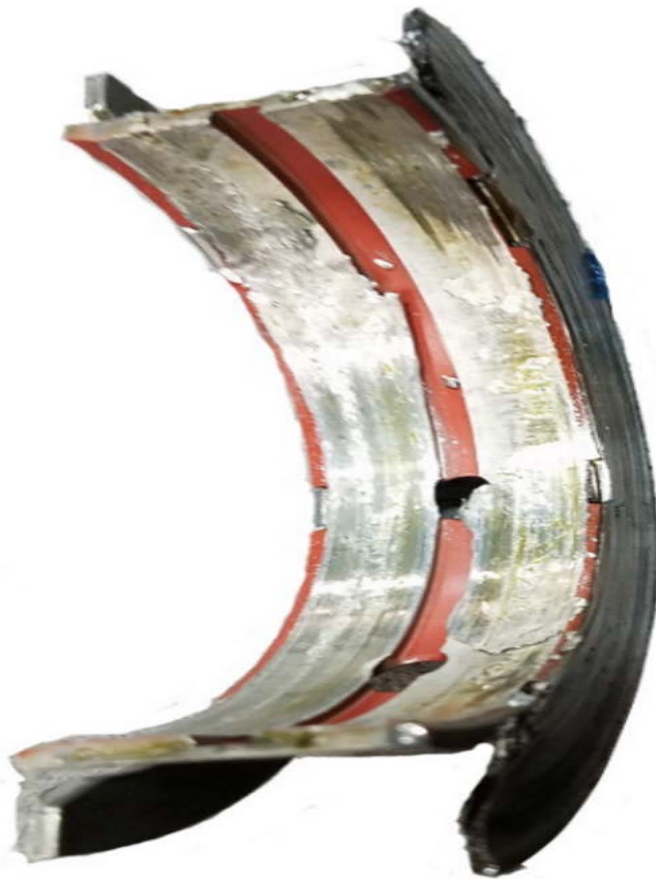
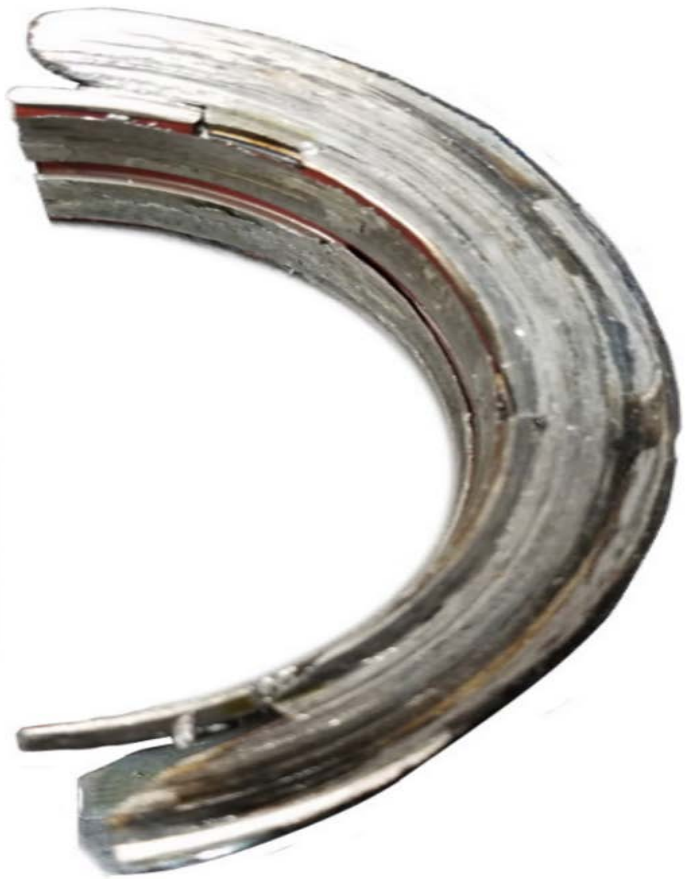
5403464

3. Inspect the thrust bearing for wear on one side and crankshaft on the corresponding mating surface. The graphic above shows an example of a damaged thrust bearing.

⇒ If wear is evident (3 vertical channels worn off), it will be necessary to replace the crankshaft, connecting rods and main bearings.

Note: It is not necessary to replace the engine assembly for this condition.

4. Refer to *Crankshaft and Bearing Removal* in SI.

If bearing damage is found and if the vehicle is equipped with a dry sump system, it will be necessary to replace the oil tank with lines and oil cooler.
