# Service Bulletin

Bulletin No.: 19-NA-220

**Subject: Loss of Propulsion, Malfunction Indicator Lamp (MIL) Illuminated - DTC P0A3F and/or P1B03 Set**

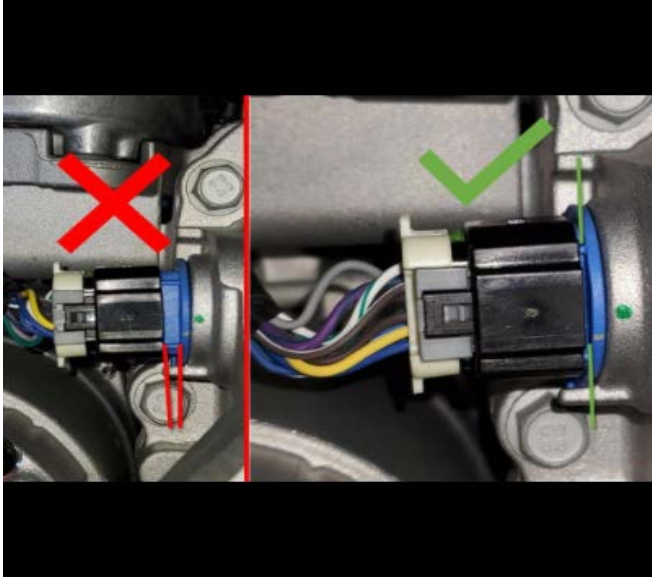
5518453

Ensure that the connector is fully seated.

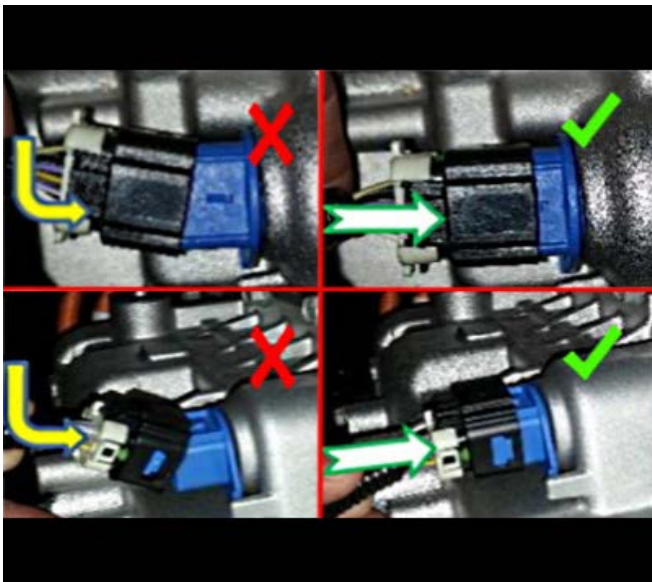
5409322

Showing both proper and improper alignment of the X2 connector.

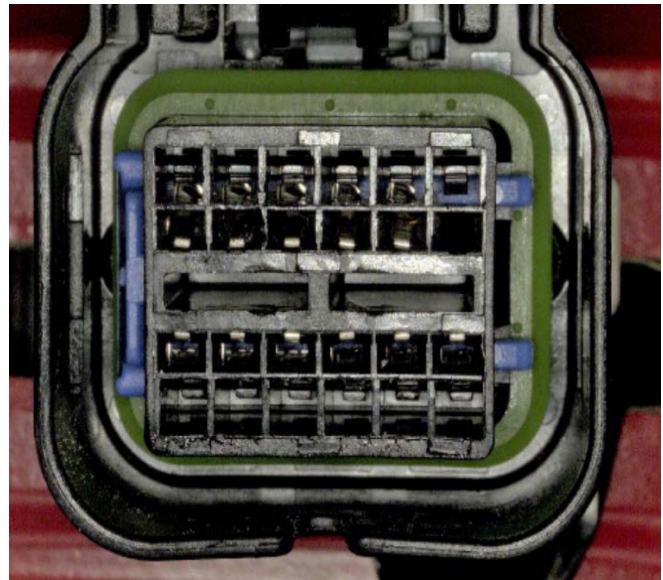
5409321

Example case of damaged terminals. Terminals do not need to have visible damage to set DTCs P0A3F and P1B03.
