Service Bulletin

Bulletin No.: 19-NA-225

Subject: Stalling, ESC Disabled Message/ESC Light/Traction Control Light Displayed on Driver Information Center (DIC), Malfunction Indicator Lamp (MIL) Illuminated - DTC C0035, C0040, C0045, C0050, C0055 and/or C0511 Set

Brand:	Model:	Model Year:		VIN:		Engine:	Transmission:
		from	to	from	to		
Chevrolet	Malibu	2019	2020			1.5L (LFV)	CVT250 Automatic (MRG)

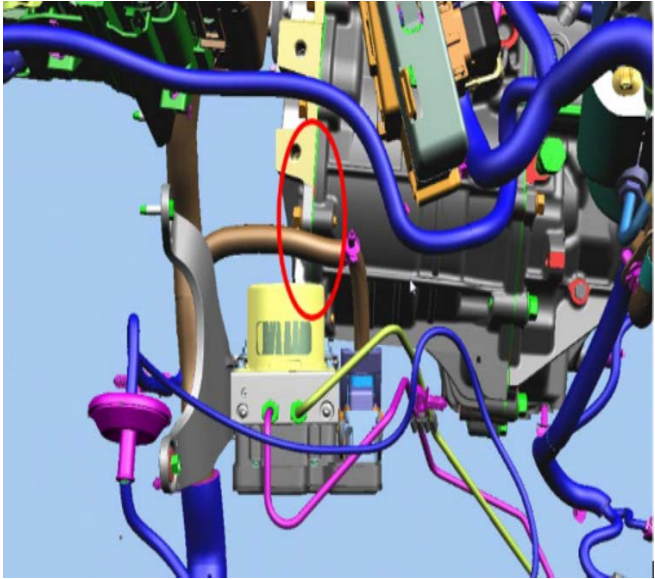
<p style="text-align: right;">5412559</p> <p>This condition may be caused by the engine harness chaffing against the top front of the transmission, below the electronic brake control module (EBCM).</p>
<p>Correction</p>	<p>If the above condition has been validated, inspection of the engine wiring harness must be done.</p> <ol style="list-style-type: none"> 1. With a suitable light, inspect the wiring harness point of contact at the transmission. <p>⇒ Refer to <i>Wire to Wire Repair</i> in SI.</p> <ol style="list-style-type: none"> 2. Using Woven Polyester Electrical Tape (PET), tape all the contact points of the harness ensuring that the tape is applied in a double layer. 3. Reposition the harness away from the transmission housing.
