Service Bulletin

Bulletin No.: 19-NA-267

Subject: Driver Information Center Welcome Logo Flickers When Entering Vehicle or Blank Head Up Display

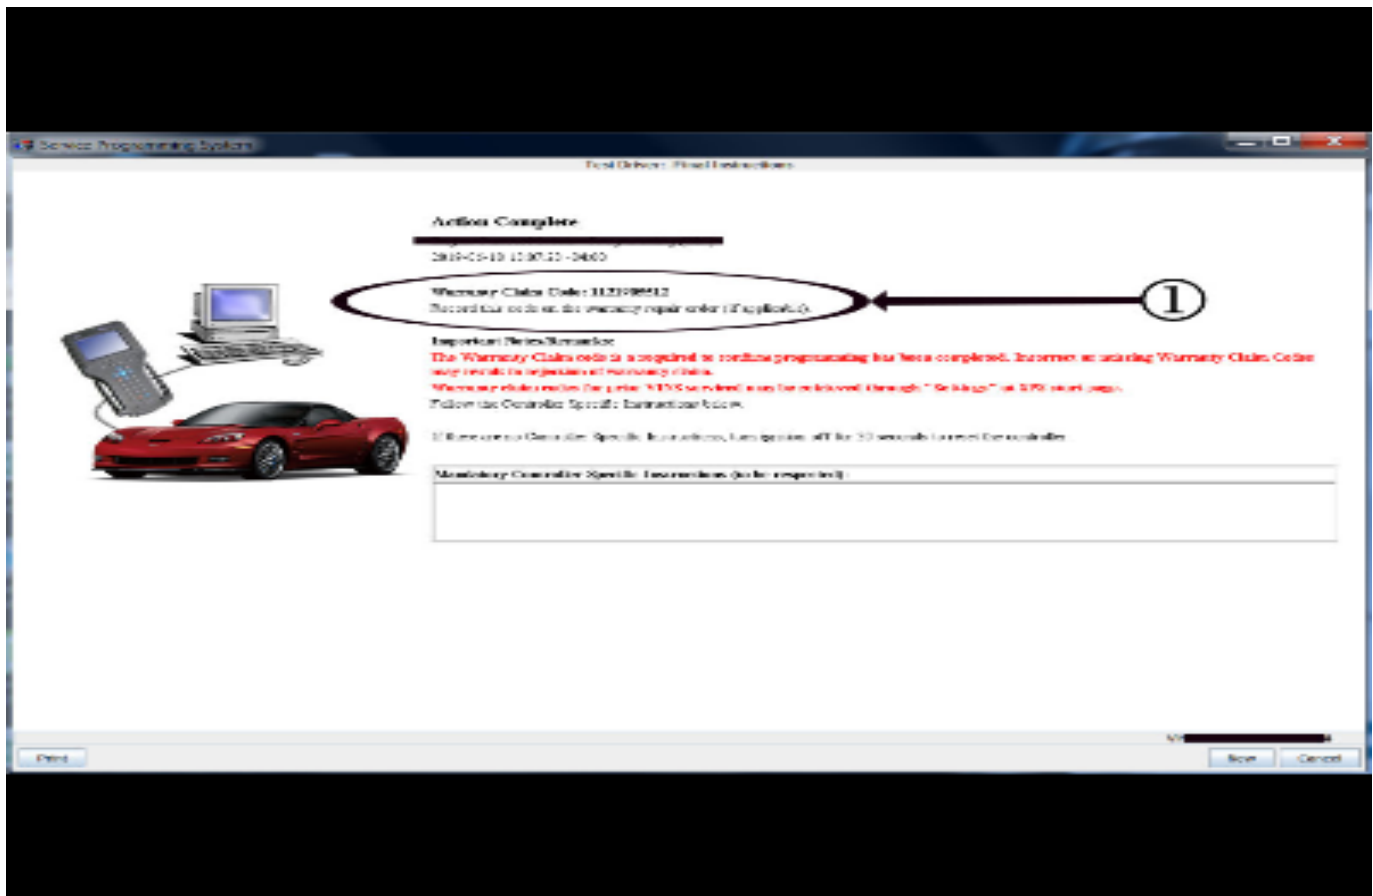
5431209

Important: To avoid warranty transaction rejections, you **MUST** record the warranty claim code provided on the SPS Warranty Claim Code (WCC) screen on the job card. Refer to callout 1 above for the location of the WCC on the SPS screen.

2. Record SPS Warranty Claim Code on job card for warranty transaction submission.
