Service Bulletin

Bulletin No.: 20-NA-007

Subject: Hoot/Moan Type Noise While Driving at Slower Speeds

Brand:	Model:	Model Year:		VIN:		Engine:	Transmission:
		from	to	from	to		
Chevrolet	Malibu	2019	2020				VT40 CVT Automatic (MRG)

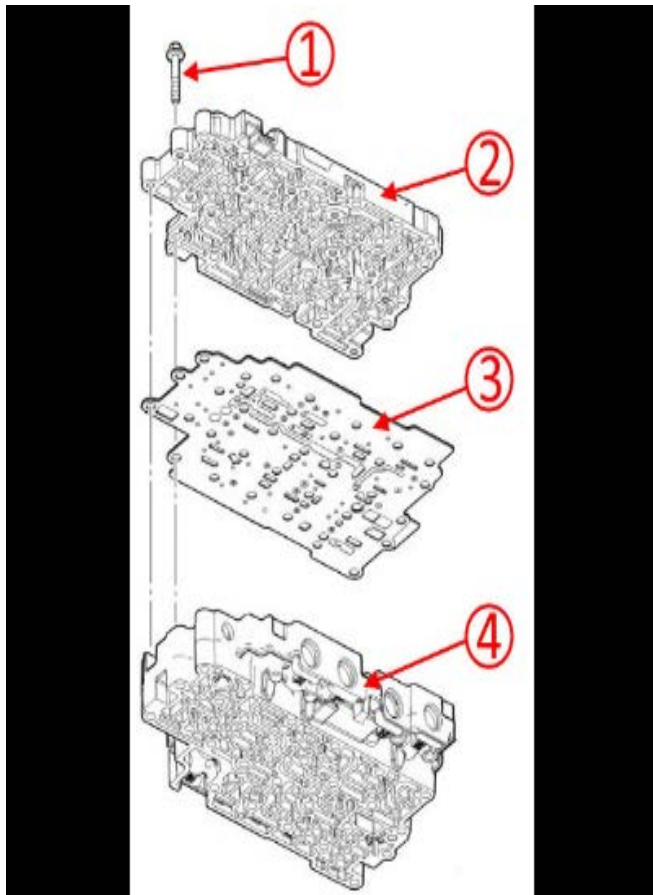
5479741

Involved Region or Country	North America, Israel, Palestine
Condition	Some customers may comment that a hoot and/or moan noise can be heard as the engine RPMs increase just off idle or during garage shifts. – This noise is primarily at cold idle and cannot be heard while driving.
Cause	This condition may be caused by the transmission fluid flowing past the orifices in the spacer plate in the valve body.
Correction	If the condition has been validated, the valve body separator plate needs to be replaced.

2. Remove the valve body bolts (1).
3. Using care, separate the spacer plate from the channel plate (2) and control valve (4).
4. Install the new spacer plate.
5. Assemble the control valve.

Tighten the bolts to 8 N•m (71 lb in).
