Service Bulletin

Bulletin No.: 20-NA-009

Subject: Slight Tire Contact When Turning on an Incline

Brand:	Model:	Model Year:		VIN:		Engine:	Transmission:
		from	to	from	to		
Buick	Encore GX (VIN M)	2020	2020

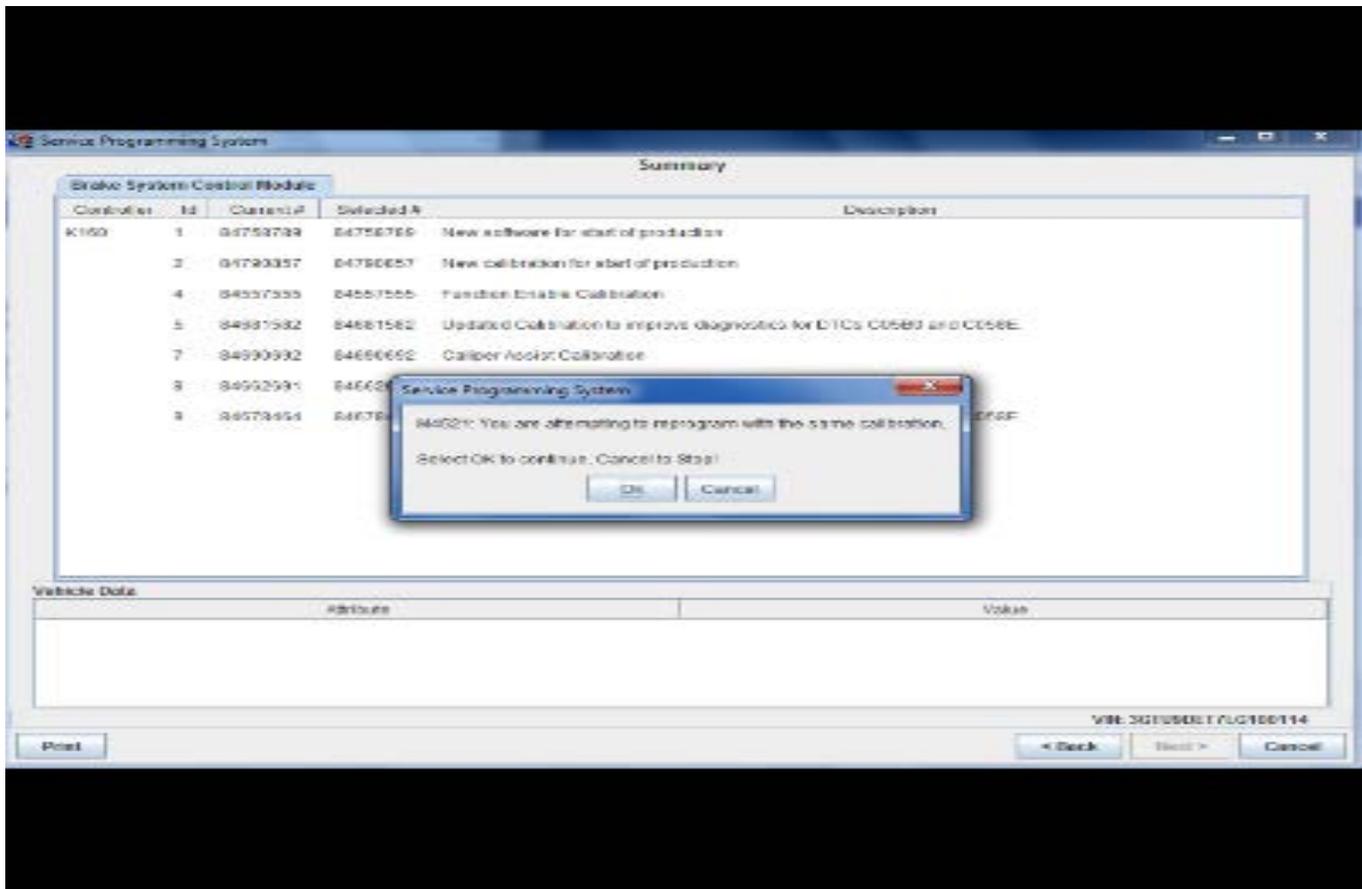
5431207

Important: If the Same Calibration/Software Warning is noted on the SPS screen, select OK and follow screen instructions. After a successful programming event, the WCC is located in the Service Programming System dialogue box of the SPS Summary screen. No further action is required. Refer to the Warranty section of the bulletin.
