Service Bulletin

Bulletin No.: 20-NA-025

Subject: Loss of Audio, Chime, or Turn Signal Click Clack, Abnormal Speaker Operation

Brand:	Model:	Model Year:		Build Dates		Engine:	Transmission:
		from	to	from	to		
Buick	Enclave	2018	2019	SOP	Prior to January 7, 2019	All	All
Chevrolet	Traverse	2018	2019

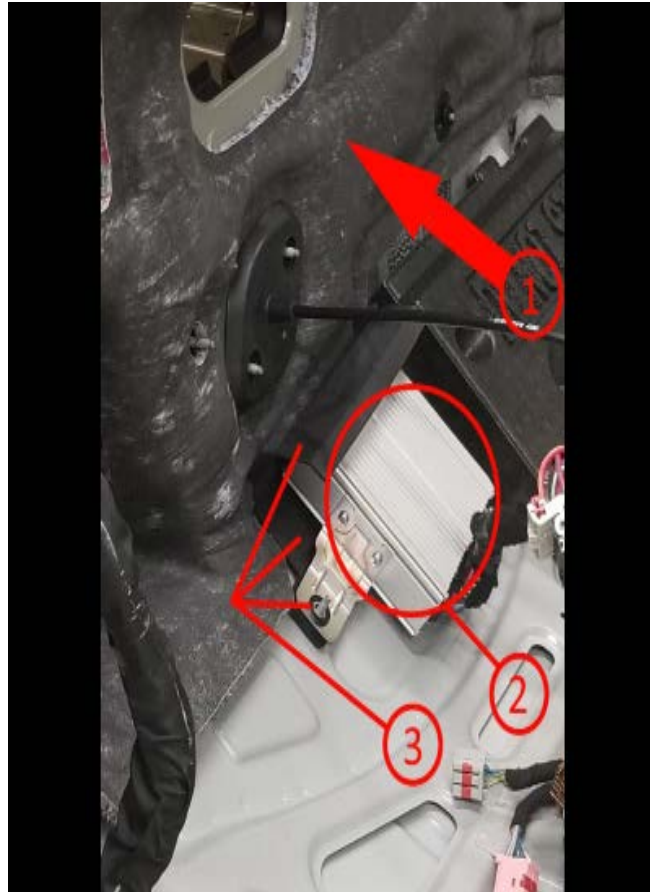
5507591

Involved Region or Country	North America, Russia, Middle East, Israel, Palestine, Chile, Columbia, Peru, Other Africa
Additional Options (RPOs)	Equipped with Standard Audio Speaker System (UQF)
Condition	Some customers may comment on one or more of the following audio symptoms: <ul style="list-style-type: none">• Loss of audio• Loss of chime• Loss of turn signal click-clack• Low or no audio from one or more speaker channels• Abnormal speaker noises
Cause	The cause of the condition may be that condensation from the HVAC system may enter the Active Noise Cancellation (ANC) module through the module vents.

1. Front of the vehicle
2. ANC module
3. ANC module secondary shield

Replace the ANC module and install an ANC module secondary shield, following the steps in the Service Procedure below.
